November 16, 2012

Mr. Steve Sutorus
Vice President, Fiscal Services
SAN BERNARDINO COMMUNITY COLLEGE DISTRICT
114 South Del Rosa Drive
San Bernardino, CA 92408

RE: SWACC PROPERTY & LIABILITY INSPECTION FOLLOW-UP AUDIT

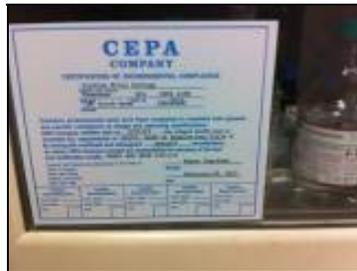
CHS Science Prep Base Room

1. Ventilation hoods should be regularly tested for airflow. Minimum average face velocity airflow of 100 linear feet per minute should be required and the sash should be marked where this airflow is obtained. Consideration should be given to providing a vane anemometer to allow lab personnel to obtain the airflow measurements themselves.

Issue closed – unit was tested on February 29, 2012.

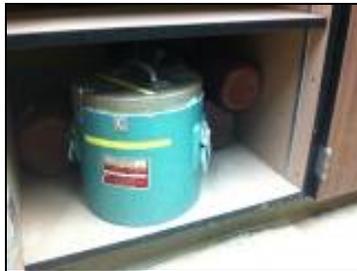
LADM 102 Storeroom

2. A container marked 'Radioactive' is located in the storeroom cabinet. This item needs to be tested and disposed of accordingly.

Issue still open – the container is still located in the storeroom cabinet.

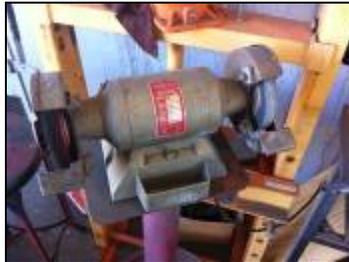
M&O Grounds

1. **Bench Grinder** – All grinders should be inspected and repaired/adjusted to meet the following requirements: a) tongue guards attached and kept adjusted to within 1/4” of the grinding wheel, b) tool rests attached and kept adjusted to within 1/8” of the grinding wheel, c) safety shields over the grinding wheels/brushes, d) safety shields equipped with lights should have bulbs in place.
