RE: SWACC PROPERTY & LIABILITY INSPECTION

SWACC PROPERTY & LIABILITY INSPECTION

PREPARED FOR
SAN BERNARDINO COMMUNITY COLLEGE DISTRICT

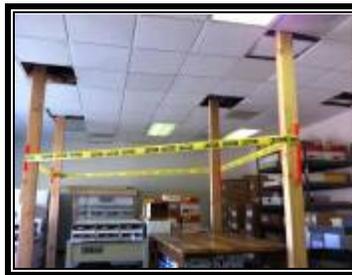
Roof Damage

Support beams have been located to ensure the roof does not deteriorate any further.

A structural engineering firm (RM Byrd and Associates) inspected the Annex Building at the request of San Bernardino Community College District. The Annex Building located at 441 West 8th Street, San Bernardino, was inspected on October 16. The purpose of the visit was to review the reported failure of two roof purlins located over the print shop on the west side of the building.

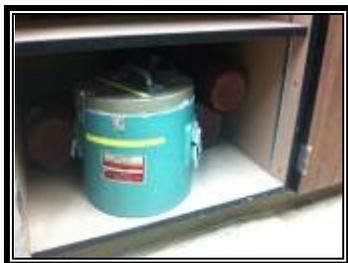
Storeroom (102)

A container marked 'Radioactive' is located in the Storeroom cabinet. This item needs to be tested and if found positive, disposed of accordingly.

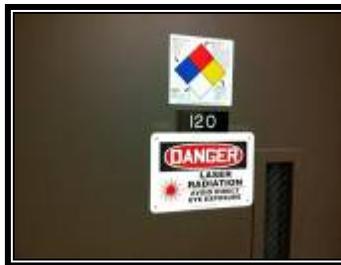
**Laboratory/Administration (LADM)****Storeroom (120)**

NFPA Signs (#) – Chemical storage rooms or areas should be clearly labeled with applicable NFPA warning signs, including number ratings.

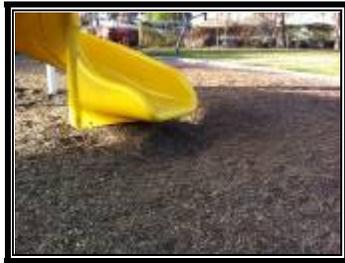
Playground East – Fall protection was found to be below the allowed fall height. Broken down, compacted or displaced loose fill surfacing material presents an elevated risk of head impact injuries. Adequate loose fill surfacing material depth should be determined based on the fall height of adjacent play equipment. Surfacing material should be added or re-distributed in this area to improve conditions and reduce this risk of head impact injuries.

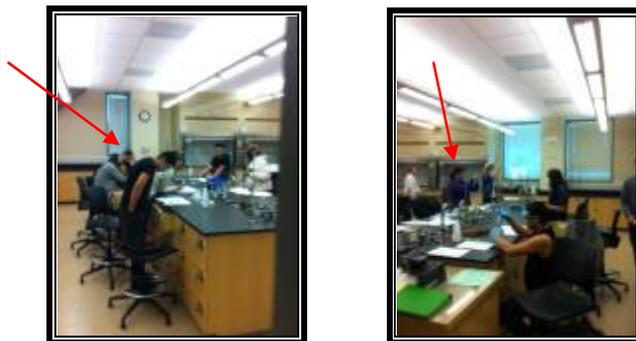
Classroom PS315

Personal Protective Equipment – Appropriate PPE should be provided and utilized when persons work with equipment, chemicals, or in areas that present an elevated risk of injury. Unfortunately, some students in the classroom were noted not to be wearing eye protection, even though the entire class was undertaking the same experiments.

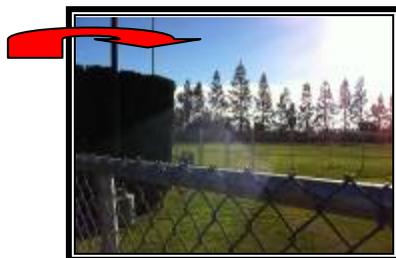
Soccer Field

Location – At present, the soccer field has been located in between the baseball field and the hammer throw zone. Concerns are that fly balls from the baseball field's right field could strike soccer players on the north end of the soccer field and hammer throws potentially landing on the south end of the soccer field.

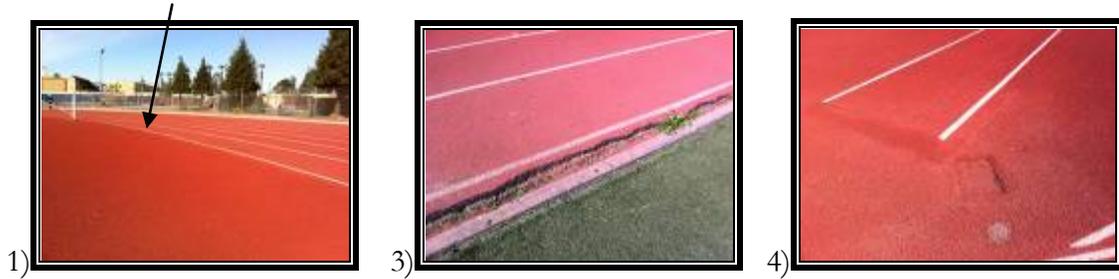
Surface Condition – Concerns regarding the condition of the track:

- 1) Unevenness at the north end of the track leads to runners jolting their backs ever so slightly, enough to be noticed.
- 2) Separation between track and 'D' zone allowing water to penetrate and raise the track.
- 3) Football cleats breaking the edging of the track, leading to water and moisture entering under the track itself and speeding up the degradation from underneath.
- 4) Raised edge at the long jump lane.
