RE: SWACC PROPERTY & LIABILITY INSPECTION

SWACC PROPERTY & LIABILITY INSPECTION

January, 2018

SAN BERNARDINO COMMUNITY COLLEGE DISTRICT

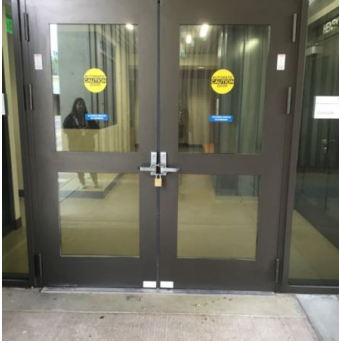
Description: The exit door to the CNTL Building Corridor 217 was chained. It is unclear why these doors are locked, but it's possible that the doors are defective and cannot be locked to the outside. Defective exit doors that do not function properly should be repaired.

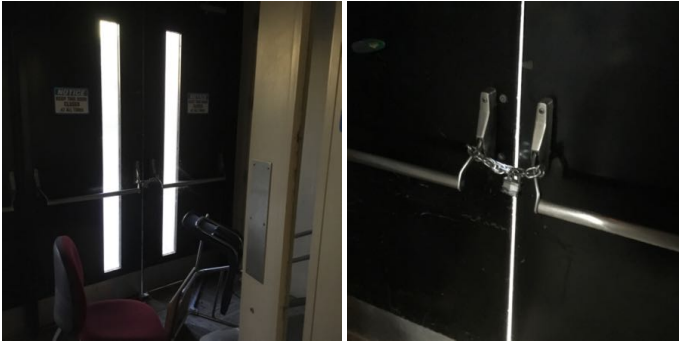
Location: San Bernardino Community College - CRAFTON HILLS COLLEGE - Gym

Description: Several exit doors in this gym are chained. It is unclear why these doors are locked, but it's possible that the doors are defective and cannot be locked to the outside. Defective exit doors that do not function properly should be repaired.

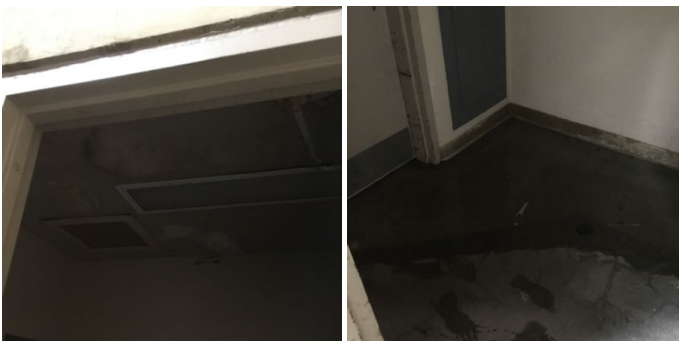
Location: San Bernardino Community College - CRAFTON HILLS COLLEGE - Gym- Locker Room

Description: The roof had water damage in the Gym. The source of the leak should be found and repaired to mitigate the water damage hazard that was observed.

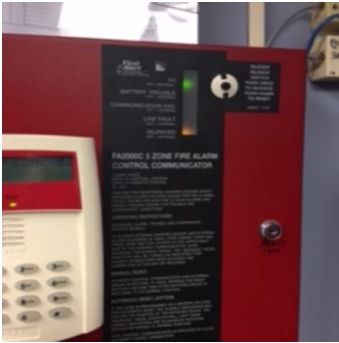
Location: San Bernardino Community College - DISTRICT OFFICE - Human Resource Reception 117

Description: The system trouble and/or system silence lights were lit on the main fire alarm panel. The fire alarm system should be operational at all times.

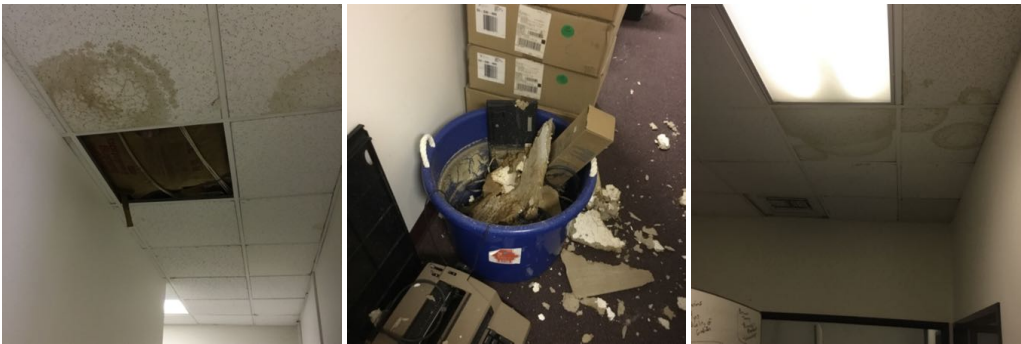
Location: San Bernardino Community College - SAN BERNADINO CCD ANNEX - Print Room

Description: The roof had severe water damage in several areas throughout the building. The source of the leak should be found and repaired to mitigate the water damage hazard that was observed.

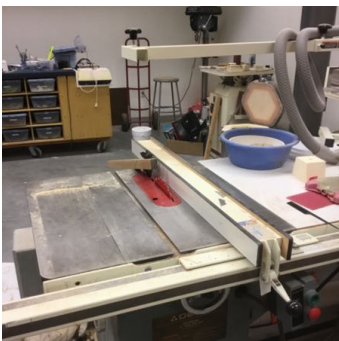
Location: San Bernardino Community College - SAN BERNARDINO VALLEY COLLEGE - Art Center Workroom Art Room 119

Description: Protective blade guards on table saws reduce the possibility of serious injury. Table saws that are missing protective guards should be taken out of service immediately. Missing protective guards should be replaced before the saw is placed back into service.

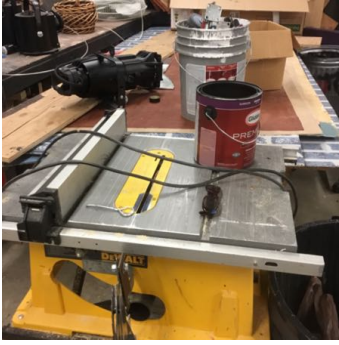
Location: San Bernardino Community College - SAN BERNARDINO VALLEY COLLEGE - Auditorium Workshop A107

Description: Protective blade guards on table saws reduce the possibility of serious injury. Table saws that are missing protective guards should be taken out of service immediately. Missing protective guards should be replaced before the saw is placed back into service.

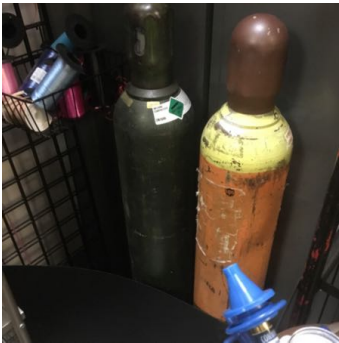
Location: San Bernardino Community College - SAN BERNARDINO VALLEY COLLEGE - CC Building Receiving

Description: Compressed gas cylinders should always be secured in the upright position with a strong securing device such as a chain, strap or clamp.

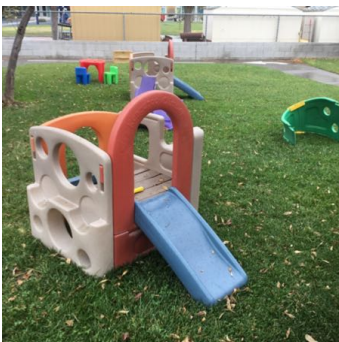
Location: San Bernardino Community College - SAN BERNARDINO VALLEY COLLEGE - CDC - Toddler Play Area

Description: There is no fall-cushioning material under the equipment. Falls from equipment located on hard compacted ground can result in serious head or neck injuries. This equipment is meant only for residential play and should be removed immediately from the school site.

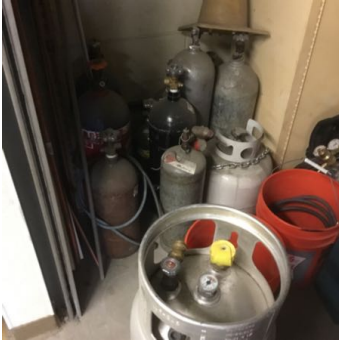
Location: San Bernardino Community College - SAN BERNARDINO VALLEY COLLEGE - Facilities/MOT Plumbing

Description: All compressed gas cylinders should be secured in the upright position with strong securing devices (chain, straps or clamps) to prevent accidental tip-over. These heavy cylinders can injure people by falling on them directly or they can become dangerous projectiles if the regulator, cylinder valve or valve connection is damaged in a fall.

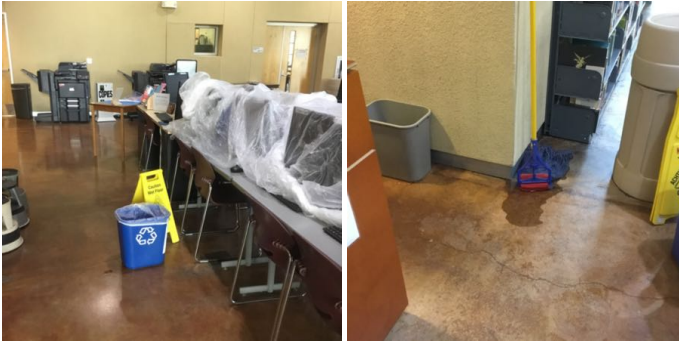
Location: San Bernardino Community College - SAN BERNARDINO VALLEY COLLEGE - LIB Building
- Library - 1st Floor

Description: The roof was actively leaking by the computers, at the Reference Database and Circulation LIB 133, in the Library. The source of the leak should be found and repaired to mitigate the water damage hazard that was observed.

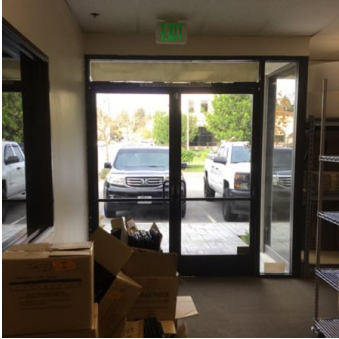
Description: Exits and emergency evacuation routes should be kept clear of obstructions at all times in order to ensure safe egress. Exit and emergency evacuation routes shall be no less than 30" wide at any point.

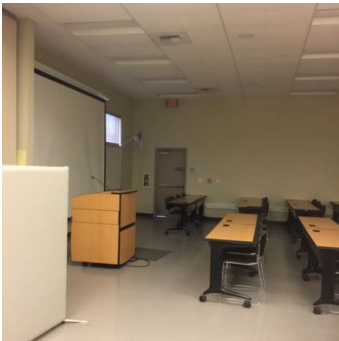
Location: San Bernardino Community College - APPLIED TECHNOLOGY TRAINING CENTER (DISTRICT OFFICE) - Lecture Hall Room 118

Description: Exit signs should remain illuminated whenever a room or area is occupied. Defective exit signs or illumination bulbs should be repaired or replaced immediately.

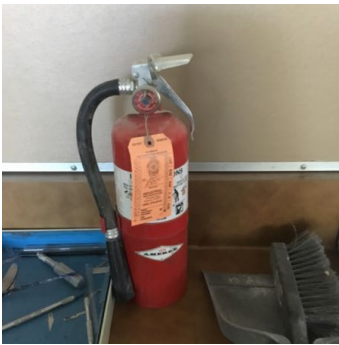
Location: San Bernardino Community College - CRAFTON HILLS COLLEGE - Art Building Art Room 130

Description: Portable fire extinguishers should be wall mounted in an easily accessible location. The distance between fire extinguishers should be no more than 75'. The fire extinguisher service tag is missing. The service tag should be replaced and updated as applicable.

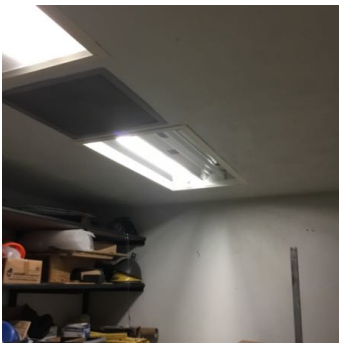
Location: San Bernardino Community College - CRAFTON HILLS COLLEGE - Art Building Art Room 133

Description: The protective len is missing from the light fixture. The len should be replaced to reduce the possibility of broken light bulbs.

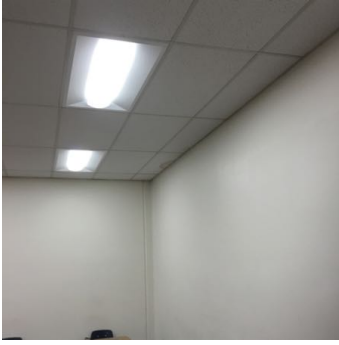
Location: San Bernardino Community College - CRAFTON HILLS COLLEGE - Art Building Room 127

Description: Some of the acoustic ceiling tiles in this area are water stained. The cause of the water stain should be identified and repairs should be made if necessary.

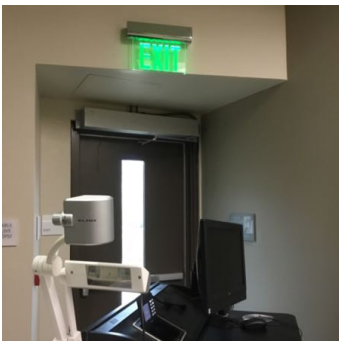
Location: San Bernardino Community College - CRAFTON HILLS COLLEGE - CNTL Building Lecture Hall 244

Description: Exits and emergency evacuation routes should be kept clear of obstructions at all times in order to ensure safe egress. Exit and emergency evacuation routes shall be no less than 30" wide at any point.

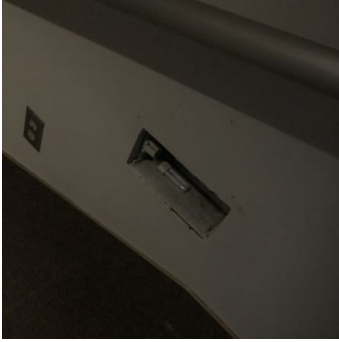
Location: San Bernardino Community College - CRAFTON HILLS COLLEGE - CNTL Building Lecture Hall 245

Description: The protective lens is missing from the light fixture. The lens should be replaced to reduce the possibility of broken light bulbs.

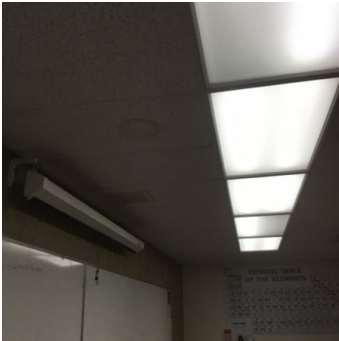
Location: San Bernardino Community College - CRAFTON HILLS COLLEGE - CNTL Building Room 247

Description: Some of the acoustic ceiling tiles in this area are water stained. The cause of the water stain should be identified and repairs should be made if necessary.

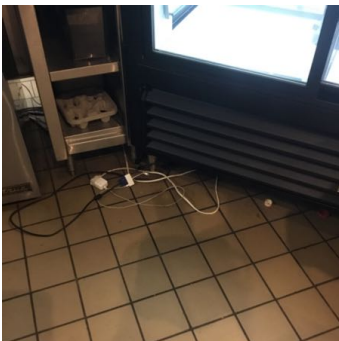
Location: San Bernardino Community College - CRAFTON HILLS COLLEGE - Crafton Center Cafe

Description: Extension cords are not designed for permanent use. The extension cord should be replaced with permanent wiring in accordance with the National Electric Code.

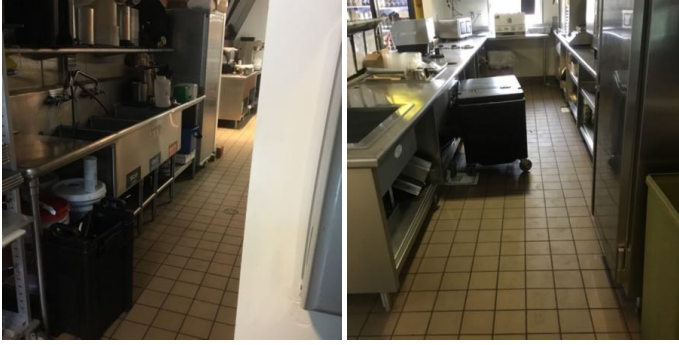
Location: San Bernardino Community College - CRAFTON HILLS COLLEGE - Crafton Center Kitchen

Description: Rubber non-slip mats should be provided at all sinks in order to eliminate the slip/fall hazard which was observed.

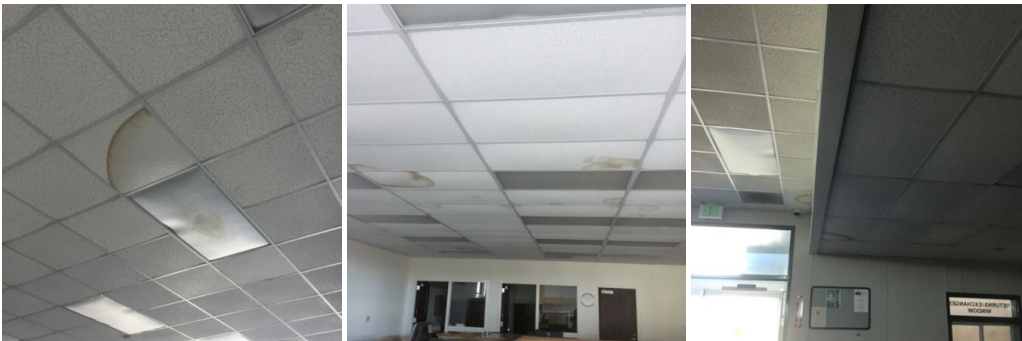
Location: San Bernardino Community College - CRAFTON HILLS COLLEGE - East Building Old Bookstore

Description: Some of the acoustic ceiling tiles in this area are water stained. The cause of the water stain should be identified and repairs should be made if necessary.

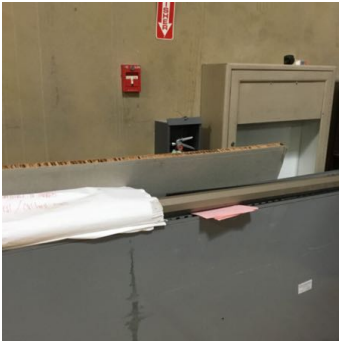
Location: San Bernardino Community College - CRAFTON HILLS COLLEGE - Gym

Description: Clear access to the fire extinguisher should be maintained at all times. Items should not be placed in front of the fire extinguisher. The fire extinguisher service tag is missing. The service tag should be replaced and updated as applicable.

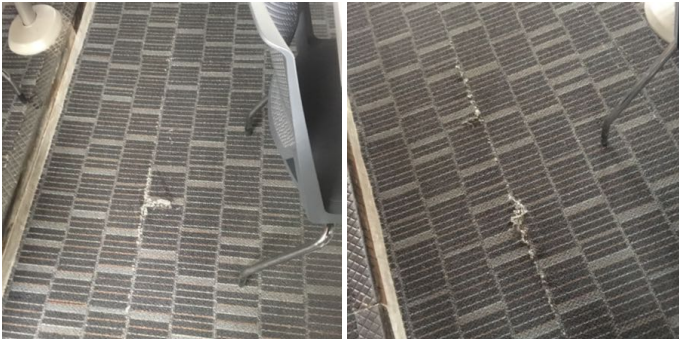
Location: San Bernardino Community College - CRAFTON HILLS COLLEGE - Learning Resource Center Auditorium Room 231

Description: Raised carpet in this area creates a trip hazard. The carpet should be repaired or replaced to reduce this hazard.

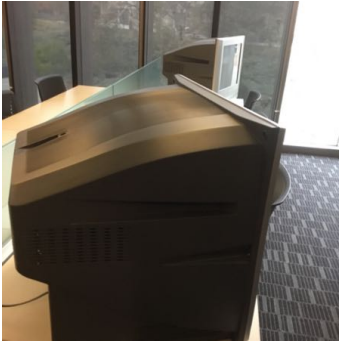
Location: San Bernardino Community College - CRAFTON HILLS COLLEGE - Learning Resource Center Library 2nd Floor

Televisions should be secured with a heavy strap or other securing device to reduce this hazard.

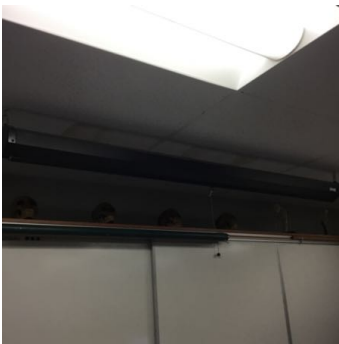
Location: San Bernardino Community College - CRAFTON HILLS COLLEGE - Learning Resource Center Storage Room 228

Description: Some of the acoustic ceiling tiles in this area are water stained. The cause of the water stain should be identified and repairs should be made if necessary.

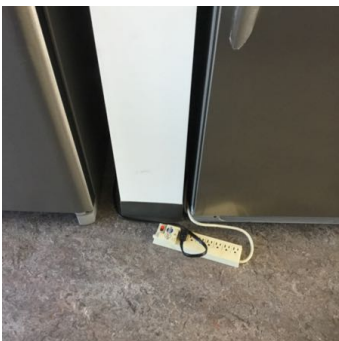
Location: San Bernardino Community College - CRAFTON HILLS COLLEGE - PSAH Building Study Lounge 217

Description: The refrigerator plugged into the surge protector can overload electrical circuits that are not designed to handle the increased electric load and can increase fire hazard. The refrigerator should be plugged directly into an electrical outlet.

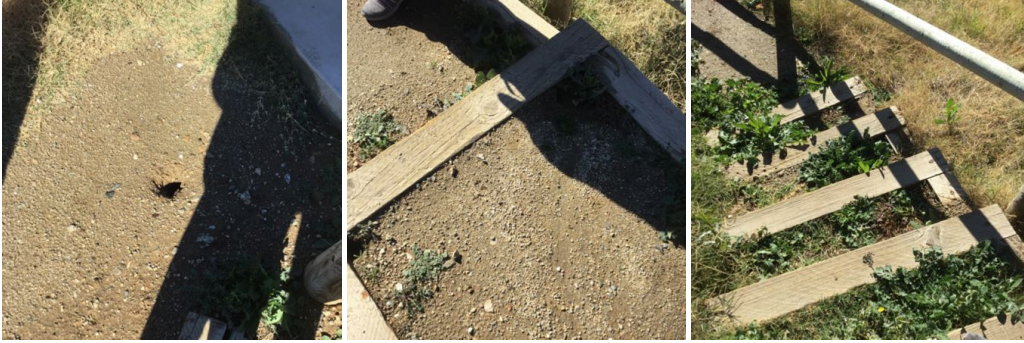
Location: San Bernardino Community College - CRAFTON HILLS COLLEGE - Stairs To KHA Building

Description: Uneven dirt surfacing in the stairs caused by erosion and overgrown weeds presents an elevated trip hazard. Uneven surfaces should be repaired to reduce this hazard.

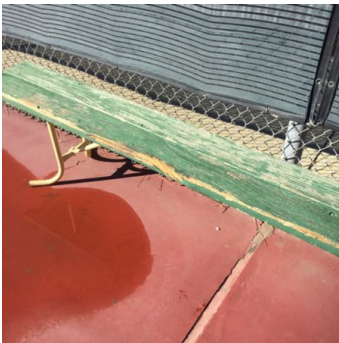
Location: San Bernardino Community College - CRAFTON HILLS COLLEGE - Tennis Courts

Description: Wood player's benches with degraded, rough or splintering surfaces present an elevated laceration or puncture hazard. Degraded, rough or splintering wood benches should be repaired or replaced to reduce this hazard.

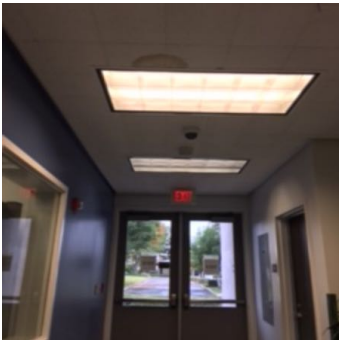
Location: San Bernardino Community College - DISTRICT OFFICE - Outside Chancellor's Office

Description: Some of the acoustic ceiling tiles in this area are water stained. The cause of the water stain should be identified and repairs should be made if necessary.

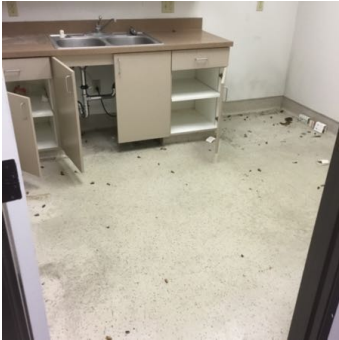
Location: San Bernardino Community College - SAN BERNADINO CCD ANNEX - Kitchen

Description: Insects can cause damage to wires, insulation and other electrical components. Insect infestations should be removed from this area.

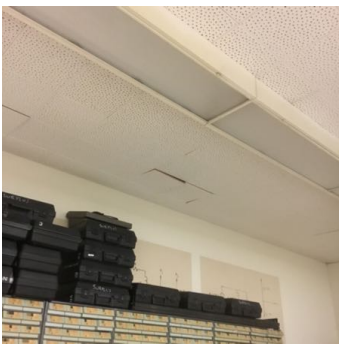
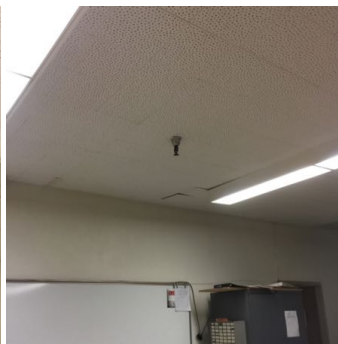
Location: San Bernardino Community College - SAN BERNARDINO VALLEY COLLEGE - Applied Technology Electronics Room 107A

Description: Loose acoustical ceiling tiles should be repaired or replaced to reduce the falling object hazard they present.

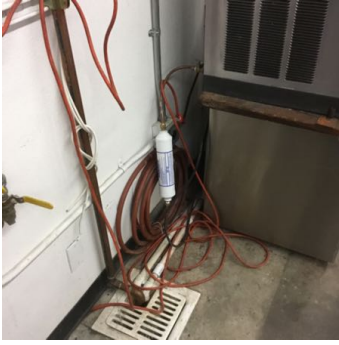
Location: San Bernardino Community College - SAN BERNARDINO VALLEY COLLEGE - Applied Technology HVAC/R LAB ROOM T-126

Description: Extension cords are not designed for permanent use. The extension cord should be replaced with permanent wiring in accordance with the National Electric Code.

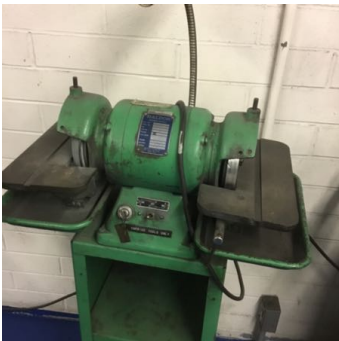
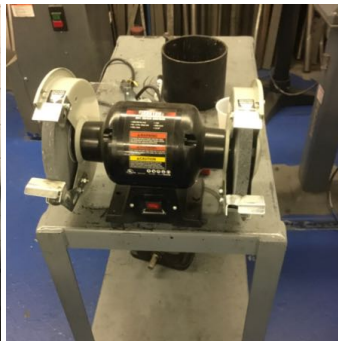
Location: San Bernardino Community College - SAN BERNARDINO VALLEY COLLEGE - Applied Technology Machine Lab Room T111A

Description: Grinders should be inspected regularly to ensure that tongue guards are attached and adjusted properly, tool rests are attached and adjusted properly, safety shields are attached and adjusted properly and lights are functioning properly. If any equipment is broken or missing the grinder should be taken out of service until it can be repaired.

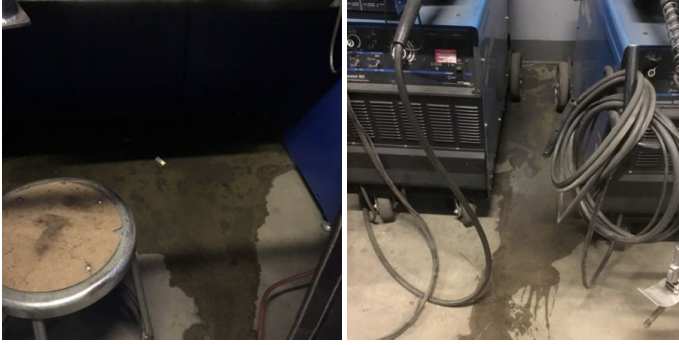
Location: San Bernardino Community College - SAN BERNARDINO VALLEY COLLEGE - Applied Technology Welding Back Lab Room 121

Description: The source of the water leak should be determined and mitigate to prevent any water damage.

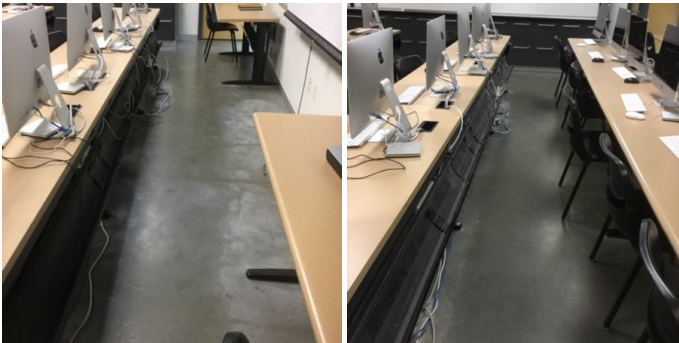
Location: San Bernardino Community College - SAN BERNARDINO VALLEY COLLEGE - Art Center
Computer Lab D Room 137

Description: Computer wiring on the floor creates a trip hazard in this area. The computer wires should be re-routed or covered with a floor wire molding to reduce this hazard.

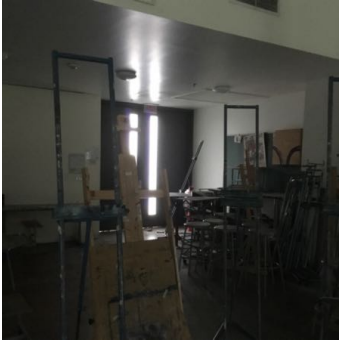
Location: San Bernardino Community College - SAN BERNARDINO VALLEY COLLEGE - Art Center
Painting & Life Drawing Studio B2

Description: Exit signs should remain illuminated whenever a room or area is occupied. Defective exit signs or illumination bulbs should be repaired or replaced immediately.

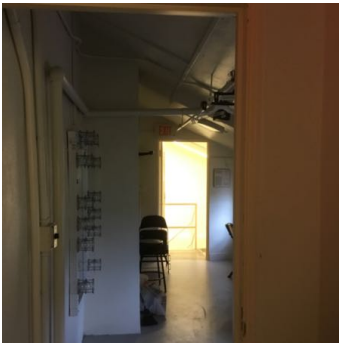
Location: San Bernardino Community College - SAN BERNARDINO VALLEY COLLEGE - Auditorium Dressing Room 3rd Floor

Description: Exit signs should remain illuminated whenever a room or area is occupied. Defective exit signs or illumination bulbs should be repaired or replaced immediately.

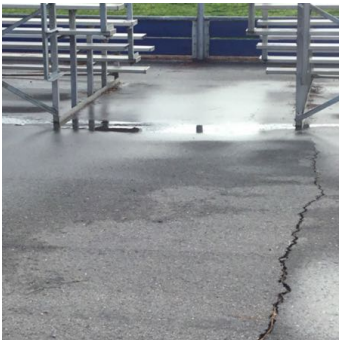
Location: San Bernardino Community College - SAN BERNARDINO VALLEY COLLEGE - Baseball Field

Description: The missing end covers from metal bleacher seats should be replaced.

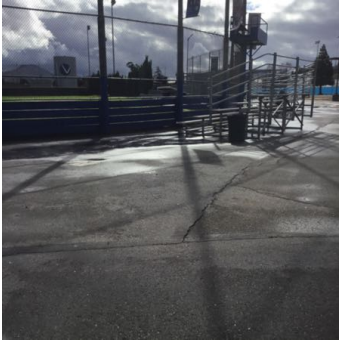
Location: San Bernardino Community College - SAN BERNARDINO VALLEY COLLEGE - Baseball Field

Description: Backstop defects such as protruding chain link fencing, exposed bolts and un-anchored structural supports present an elevated risk of injury to students. Defective backstops should be taken out of service until repairs can be made.

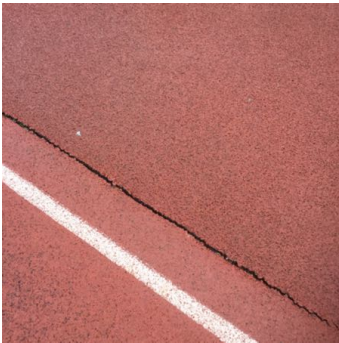
Description: Inadequate conditions occur when raised edges and voids are present in unitary tile or pour in place surfacing material. Raised edges present an elevated trip hazard. Raised edges and voids in unitary tile or pour in place surfacing material should be repaired to improve conditions.
