PLAYGROUND SAFETY INSPECTION REPORT

PREPARED FOR
SAN BERNARDINO CCD
CHILD DEVELOPMENT CENTERS

DAVID RAYMOND, CPSI
SR. LOSS CONTROL CONSULTANT

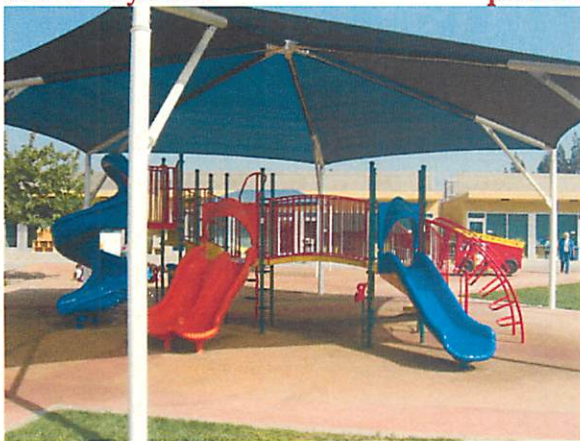
photo 1

The surface material is unitary pour in place which meets ASTM and ADA guidelines and compliance. Observed no visible issues with the equipment at the time of the inspection.

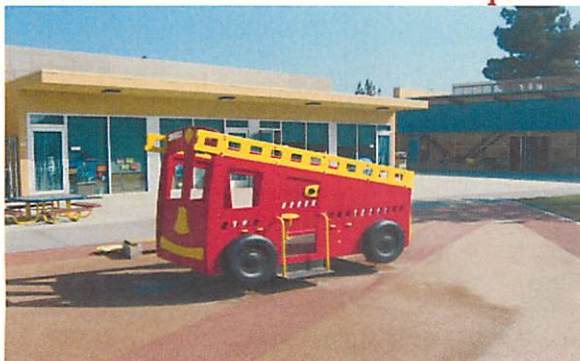
photo 2

Observed no visible issues with the equipment at the time of the inspection.

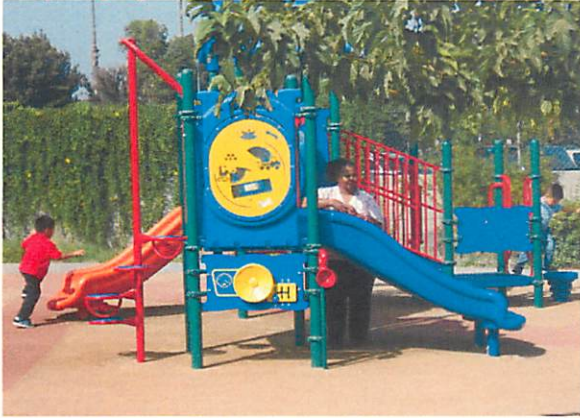
photo 3

Observed no visible issues with the equipment at the time of the inspection.

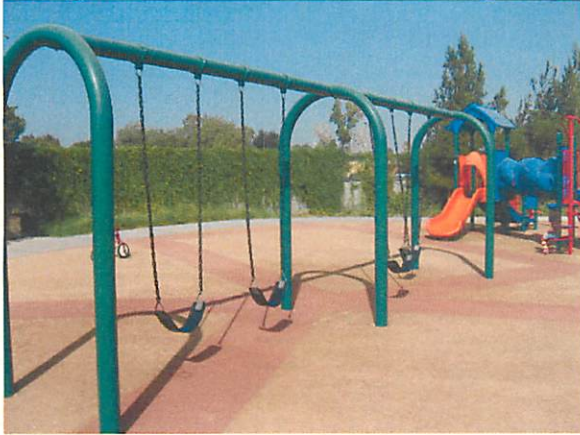
photo 4

Observed no visible issues with the equipment at the time of the inspection.

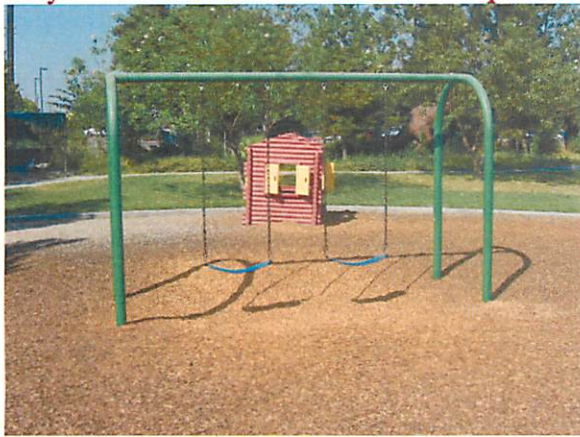
photo 5

The wood chips used to provide fall protection below the play equipment was shallow in areas. The fall cushioning depth should be maintained at least to the level of the marks on the support structure

throughout the entire fall zone. The height of the equipment should determine the type and depth of the fall protection material selected. In order to provide suitable fall protection the District should review Table 1 (Critical Heights of Loose-Fill Materials) in the CPSC *Handbook for Public Playground Safety*.

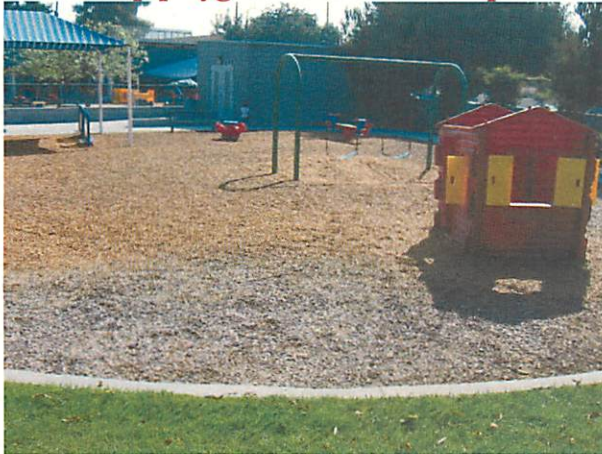
Wood chip playground area photo 6

The wood chip surface material should be replenished specifically near the asphalt border. There is an approximate 8" drop into the play area.

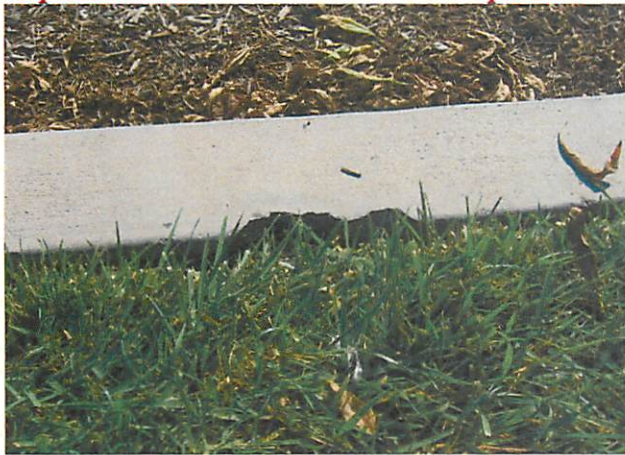
Asphalt border photo 7

The asphalt border is cracked and broken. This should be repaired.

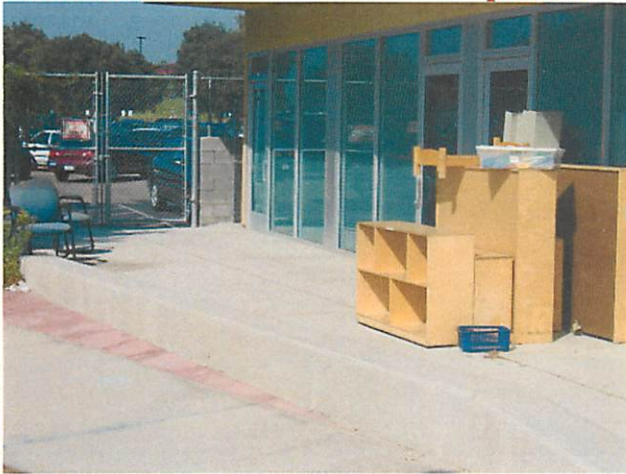
photo 8

The unsecured items are in the area of children's play and could present an inadvertent tip-over. The items should be properly stored or removed.

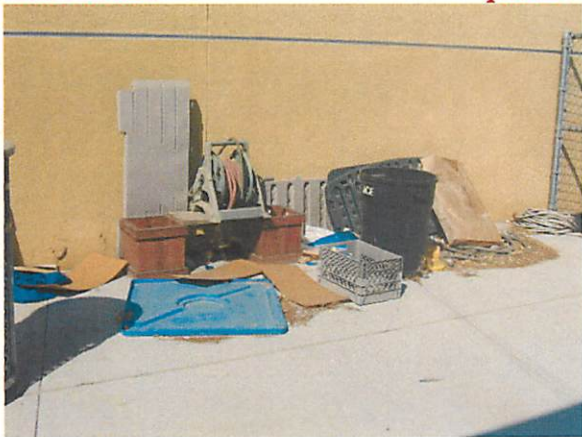
photo 9

This area is between the 2 classroom buildings and is accessible to the children. Housekeeping needs to improve and the items either properly stored or removed.

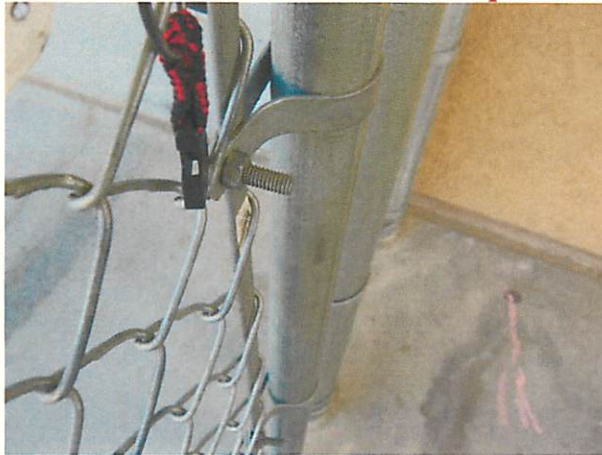
photo 10

The bolts pose potential eye protrusions and impalement hazards and should be cut to a length less than 2 threads (CPSC 9.2). **This hazard was observed throughout the perimeter of the chain link fence.**

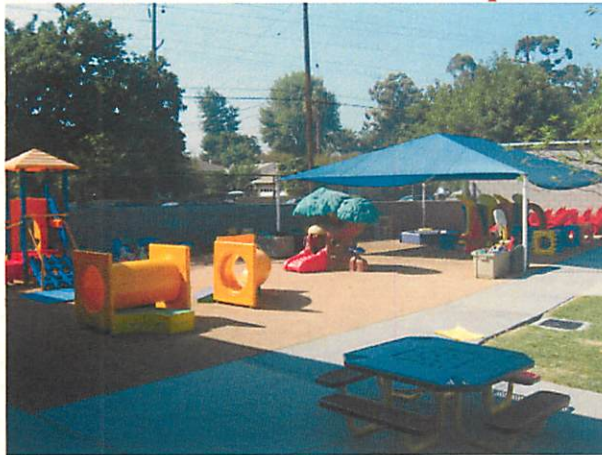
photo 11

Observed no visible issues with the equipment and surrounding area at the time of the inspection.

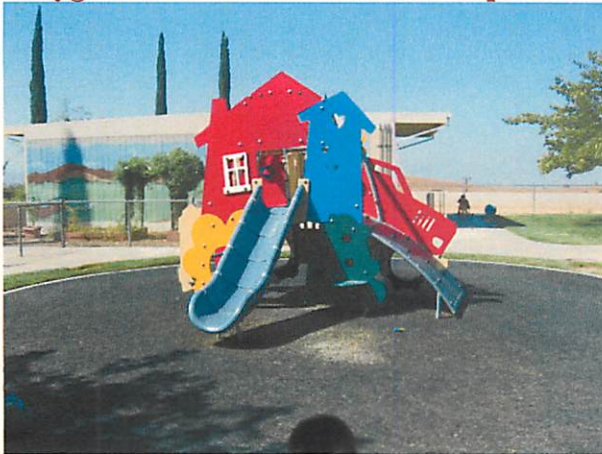
photo 12

Observed no visible issues with the equipment and surrounding area at the time of the inspection.

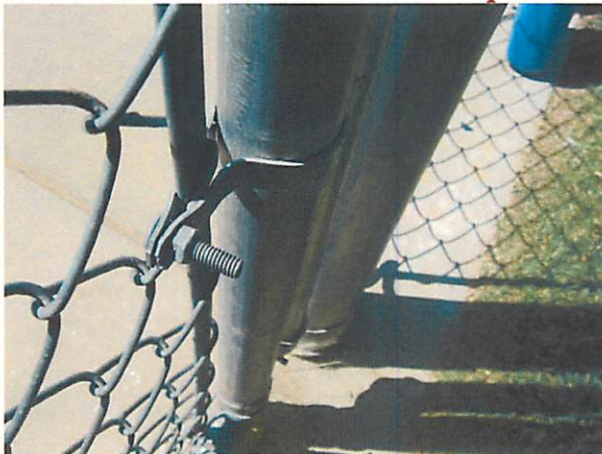
photo 13

The bolts pose potential eye protrusions and impalement hazards and should be cut to a length less than 2 threads (CPSC 9.2). **This hazard was observed throughout the perimeter of the chain link fence.**

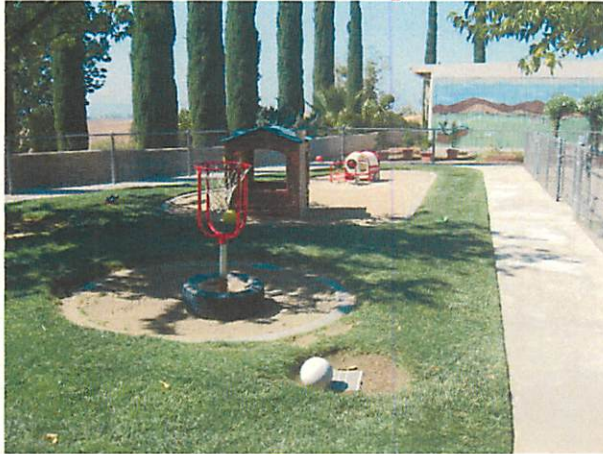
photo 14

Observed no visible issues with the equipment and surrounding area at the time of the inspection.
