# Volume 1

# Master Plan

CRAFTON HILLS COLLEGE MASTER PLAN  
SAN BERNARDINO COMMUNITY COLLEGE DISTRICT

Volume 3 Existing Facilities Assessment

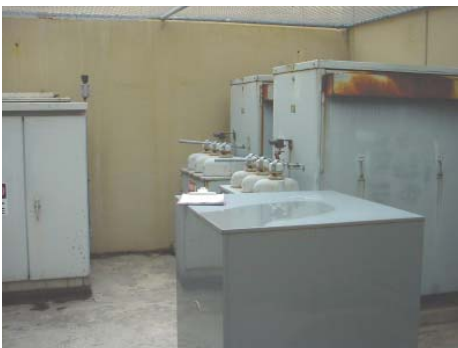
Figure 9 – Outdoor sub-station.

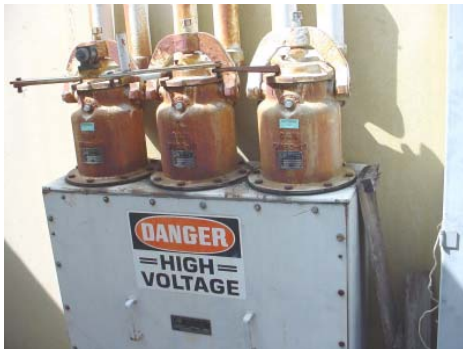
- The existing 5KV oil-filled fuse cut-outs are discontinued models from G&W and no replacement parts are available. These equipment are in excess of their life expectancy. At this time, these equipment are still in good working condition and there is no immediate need of replacement. However, if any of the building will require renovations, replacement of all existing electrical equipment is strongly recommended.

Figure 10 – Oil-filled fuse cut-outs.

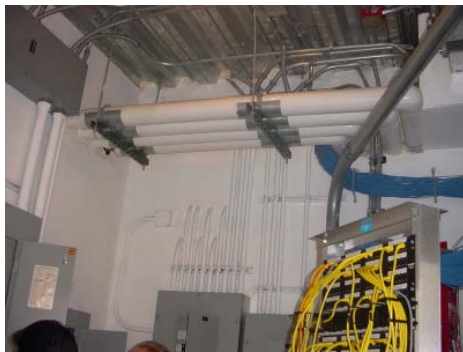
Figure 12 – HVAC pipes above electrical panel.

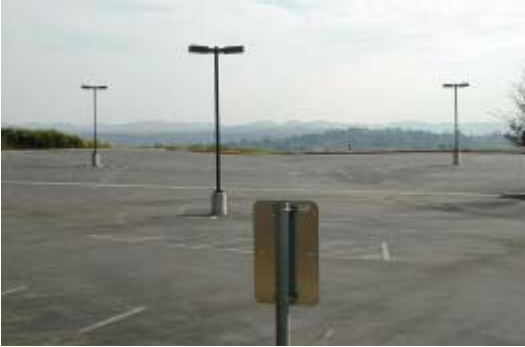
Figure 1.2 – Child Development parking – Low, sparse fixtures inadequate for area of parking lot.

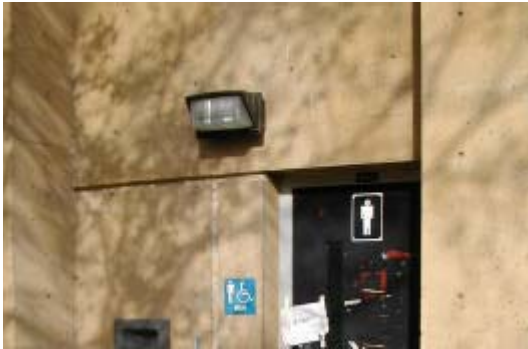
Figure 2.1 – Wall pack with prismatic refractor – visible lamp partially blinds pedestrians.

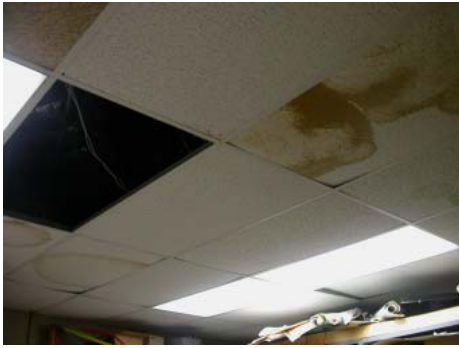
**Water damaged ceiling**

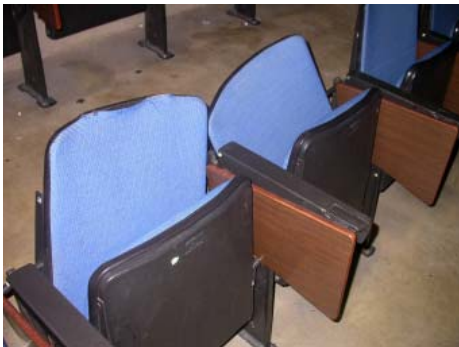
**Lecture hall seating** - Many seats and tablet arms in the lecture halls are damaged.

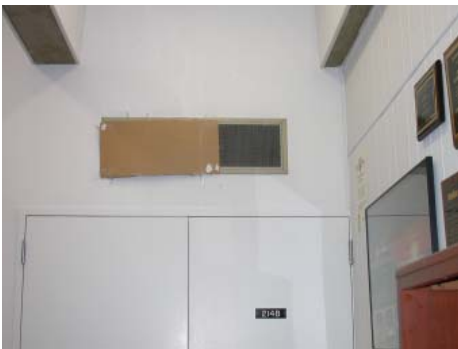
Supply air register - Occupants have partially blocked register as a means of controlling air flow.
