RE: SWACC PROPERTY & LIABILITY INSPECTION

SWACC PROPERTY & LIABILITY INSPECTION

JANUARY 2024

SAN BERNARDINO COMMUNITY COLLEGE DISTRICT

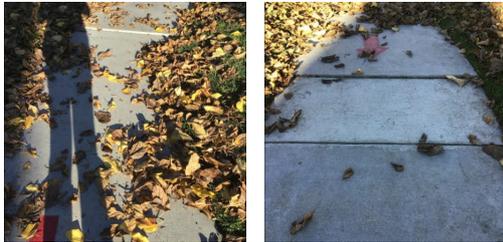
Description: Raised or cracked sections of asphalt/concrete present a trip hazard and should be repaired to reduce this hazard.

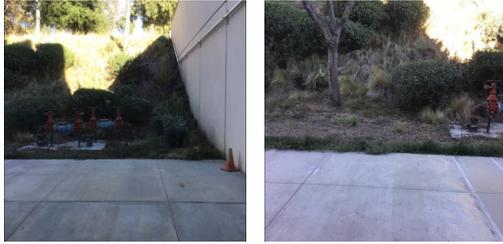
measures (ditches, canals, culverts, grates, etc.) should be in place and on a preventative maintenance program to ensure they are intact, clear of debris and functioning properly.

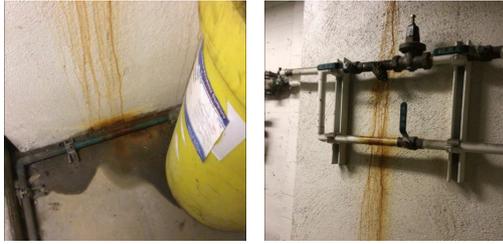
Description: There was a leak in this area at the time of the inspection. The source of the leak should be found and repaired to mitigate the water damage hazard that was observed.

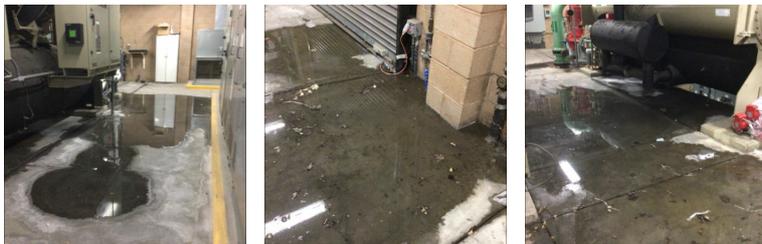
Description: The leaking pipes in this area should be repaired or replaced to reduce the possibility of flooding and water damage.

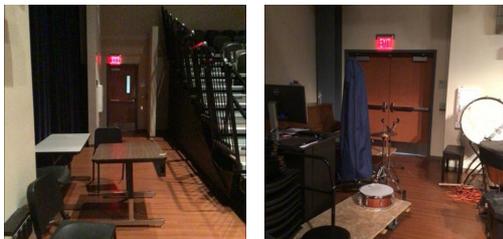
Description: Aisles and passageways were obstructed which could impede emergency egress. Aisles and passageways should be kept clear at all times and have a minimum width of 30 inches.

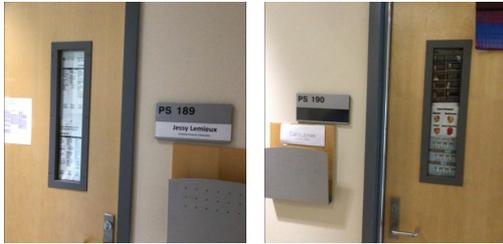
Description: In an effort to avoid sexual assault/molestation concerns, office windows should not be obstructed with paper or other material. Blinds or window coverings should be open while students are present, especially during one-on-one staff-student interaction. Office doors should remain open as well.

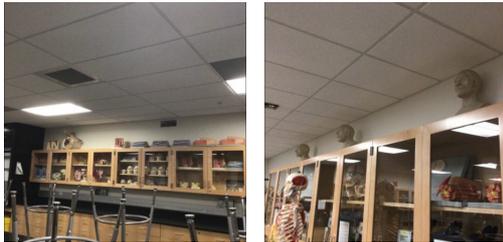
Description: The heavy items stored on top of cabinets or overhead shelves present an elevated risk of struck by injuries. They can also block emergency egress if they fall to the floor. Heavy items should be stored at a lower level to reduce this hazard. Other items stored overhead should be secured in a manner that prevents them from falling.

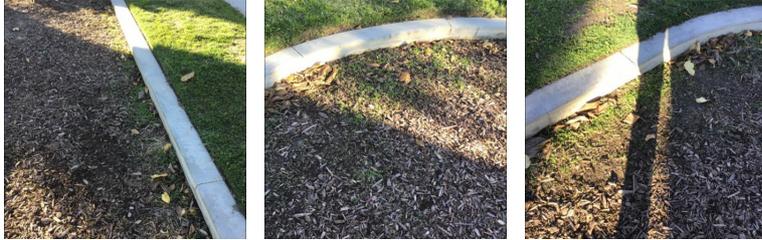
Description: Broken down, compacted or displaced loose-fill surfacing material presents an elevated risk of head impact injuries. Adequate loose-fill surfacing material depth should be determined based on the fall height of adjacent play equipment. Surfacing material should be added or re-distributed in this area to improve conditions and reduce risk of head impact injuries.

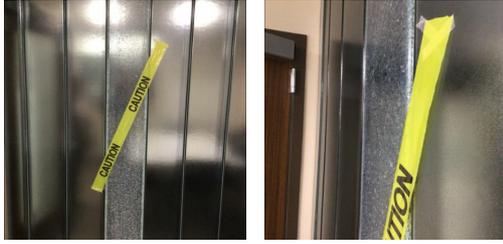
Description: The glass wall was broken and presents an elevated risk of laceration. The glass should be

replaced to reduce the associated risk.

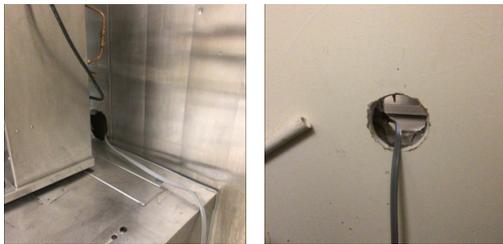
Description: The appliance cord should not be running through the hole in the wall due to the electrical/fire hazard it presents.

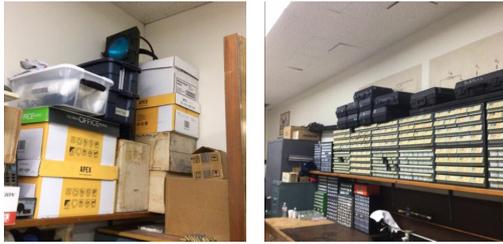
Description: The heavy items stored on top of cabinets or overhead shelves present an elevated risk of struck by injuries. They can also block emergency egress if they fall to the floor. Heavy items should be stored at a lower level to reduce this hazard. Other items stored overhead should be secured in a manner that prevents

them from falling.

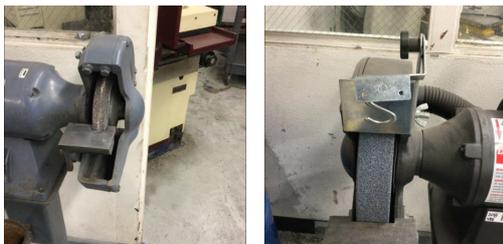
Description: Grinders should be inspected regularly to ensure that tongue guards, tool rests, and safety shields are attached and adjusted properly. If equipment is broken or missing, it should be taken out of service until it is repaired or replaced.

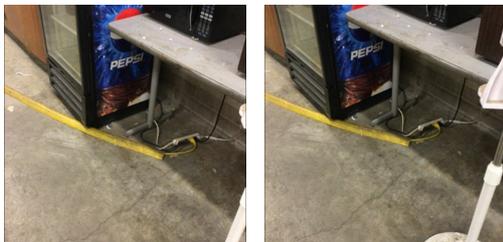
Description: 1. Connecting extension cords and/or multi-outlet power strips end to end presents an elevated risk of fire or circuit overload. 2. Extension cords are not designed for permanent use. The extension cord should be replaced with permanent wiring in accordance with the National Electric Code.

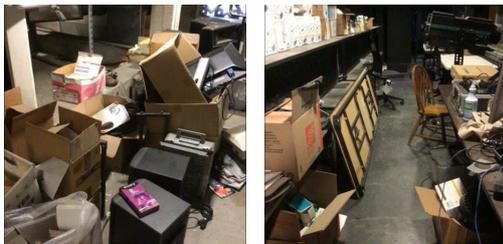
Description: Housekeeping should be improved. The area should be kept in a clean and orderly condition. Aisles and passageways should be kept clear and in good repair.

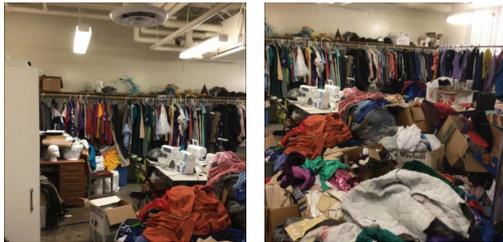
Description: Housekeeping should be improved. The area should be kept in a clean and orderly condition. Aisles and passageways should be kept clear and in good repair.

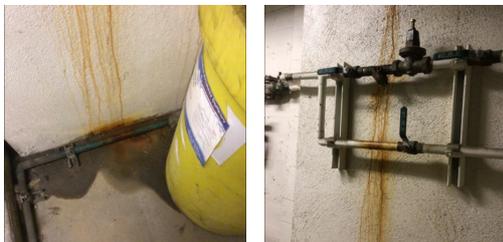
Description: There was a leak in this area at the time of the inspection. The source of the leak should be found and repaired to mitigate the water damage hazard that was observed.

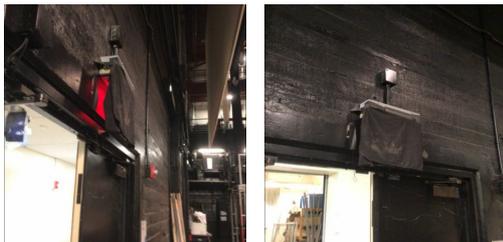
Description: Exit routes are not clearly identified in this area. You are unable to see the exit sign in the auditorium due to the black fabric being in front of the sign. Large assembly rooms must have all exits clearly identified.

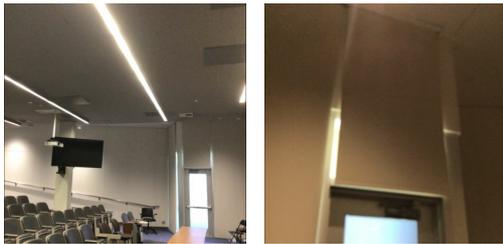
Description: Exit routes are not clearly identified in this area. You are unable to see the exit sign in the lecture classroom due to the blinds being in front of the sign. Large assembly rooms must have all exits clearly identified.

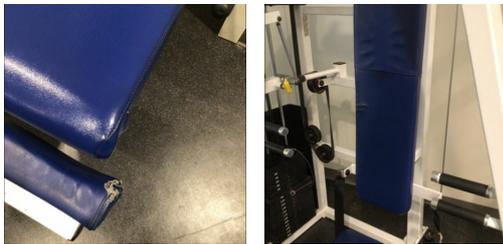
Description: Equipment pads were in various degrees of wear. Pads should not be torn or worn through to minimize the growth of bacteria.

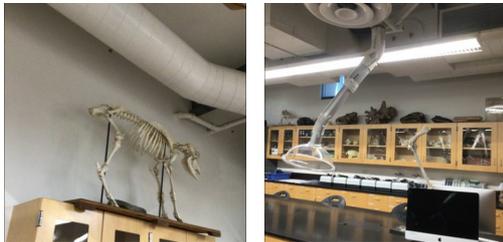
Description: The heavy items stored on top of cabinets or overhead shelves present an elevated risk of struck by injuries. They can also block emergency egress if they fall to the floor. Heavy items should be stored at a lower level to reduce this hazard. Other items stored overhead should be secured in a manner that prevents them from falling.

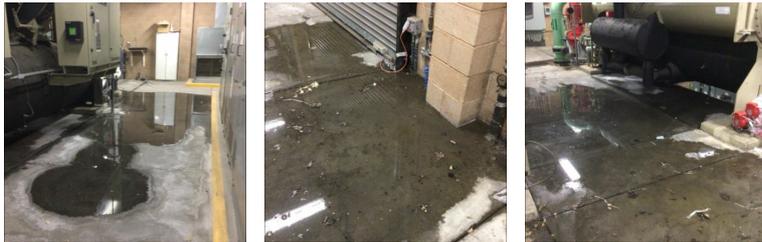
Description: The leaking pipes in this area should be repaired or replaced to reduce the possibility of flooding and water damage.

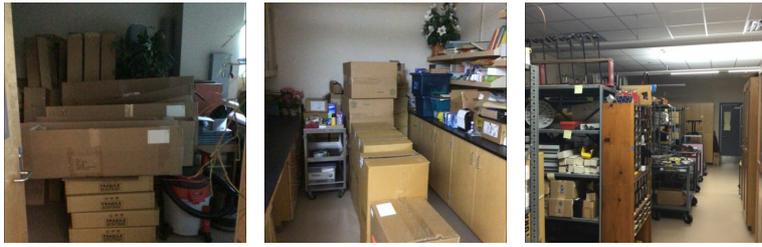
Description: Housekeeping should be improved. The area should be kept in a clean and orderly condition. Aisles and passageways should be kept clear and in good repair.

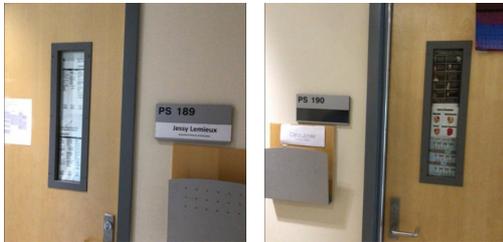
Description: In an effort to avoid sexual assault/molestation concerns, office windows should not be obstructed with paper or other material. Blinds or window coverings should be open while students are present, especially during one-on-one staff-student interaction. Office doors should remain open as well.
