# Volume 1

# Master Plan

CRAFTON HILLS COLLEGE MASTER PLAN  
SAN BERNARDINO COMMUNITY COLLEGE DISTRICT

Volume 3 Existing Facilities Assessment

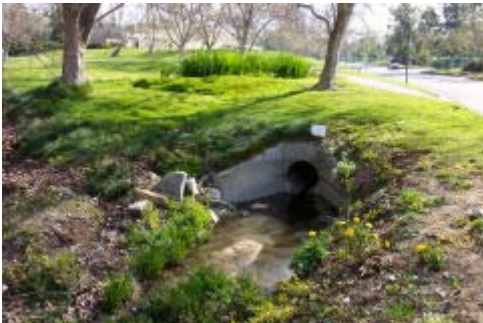
Figure 3 - Concrete headwall discharging site storm drain to open channel located along the northerly side of Campus Drive.

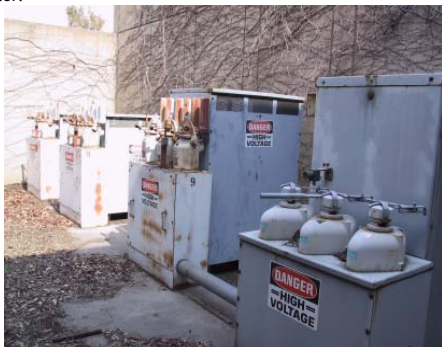
Figure 4 – Main service equipment.

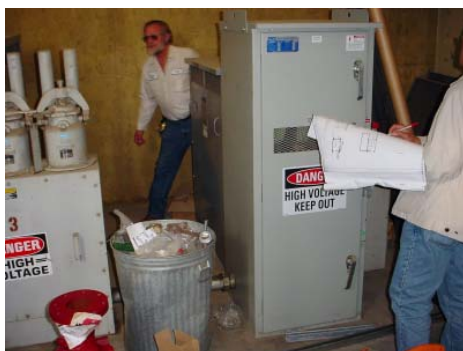
Figure 11 – Indoor service equipment.

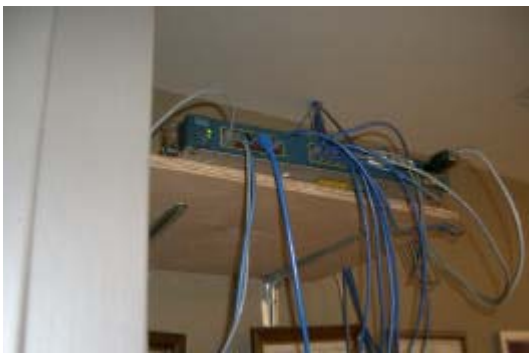
Figure 2 – Cable is distributed from an equipment location through a hole in the ceiling and to outlet locations.

The cabling is generally in good condition but is exposed in many classroom installations. It is recommended that new and renovated buildings include dedicated pathway infrastructure for the distribution of communications. The District is working to standardize on the installation of AMP Category 6 cabling. It is recommended that a standard cabling specification and installation design be developed for use by Architectural and engineering design teams working on new and renovated building projects.

It is recommended that new riser and horizontal pathways be installed as part of existing building renovations. New pathways should be based on a District standard for distribution requirements.

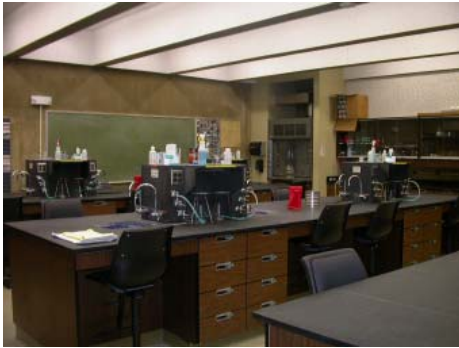
**Lab 201** - Non-compliant seating and fixtures.

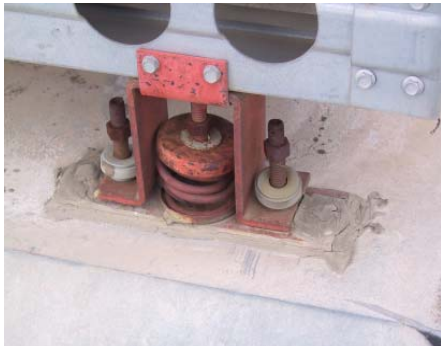
**Figure 1** – Example of vibration isolators that are shot and need to be replaced.

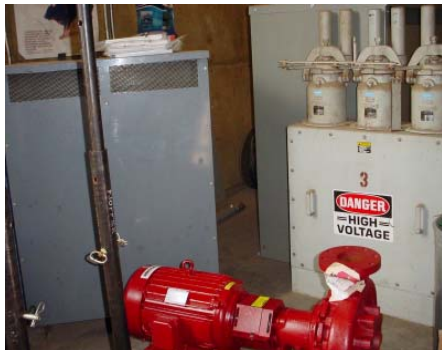
Figure 3 – Oil-filled fuse cutouts

- The oil-filled fuse cut-outs are discontinued models from G&W and no replacement parts are available. These equipment are in excess of their life expectancy. At this time, these equipment are still in good working condition and there is no immediate need of replacement. However, if any of the building will require renovations, replacement of all electrical equipment is strongly recommended.

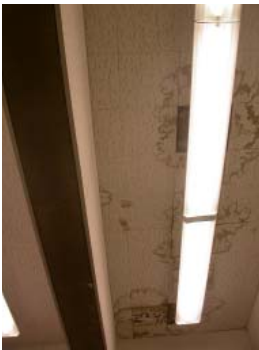
Water damage at ceiling

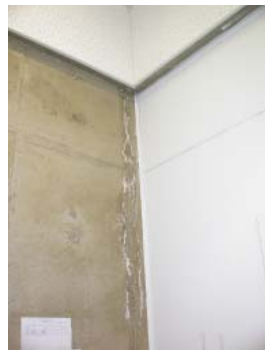
Water damage at wall
