RE: SWACC PROPERTY & LIABILITY INSPECTION

SWACC PROPERTY & LIABILITY INSPECTION

January, 2018

SAN BERNARDINO COMMUNITY COLLEGE DISTRICT

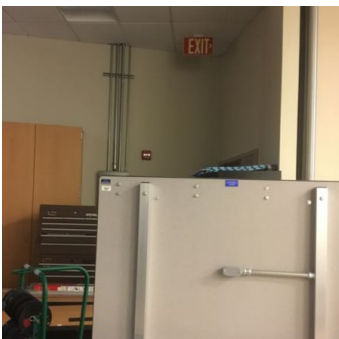
Description: Exits and emergency evacuation routes should be kept clear of obstructions at all times in order to ensure safe egress. Exit and emergency evacuation routes shall be no less than 30" wide at any point.

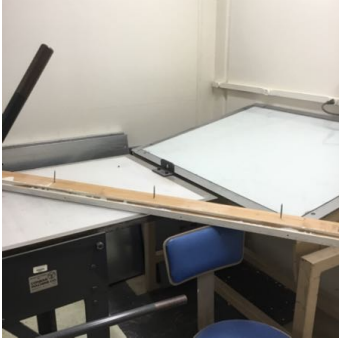
Location: San Bernardino Community College - CRAFTON HILLS COLLEGE - Art Building Art Room

Description: The wooden boards with the nails sticking out creates a protrusion hazard. The nails should be removed from the board to eliminate the potential protrusion hazard that it presents.

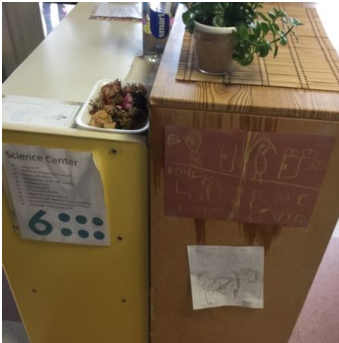
Description: Unsecured bookcases and storage cabinets present an elevated risk of struck by injuries. They can also block emergency egress if they tip over. Bookcases and storage cabinets should be secured in a manner that prevents them from tipping over to reduce this hazard.

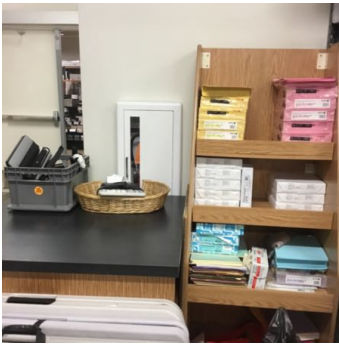
Description: Clear access to the fire extinguisher should be maintained at all times. Items should not be placed in front of the fire extinguisher.

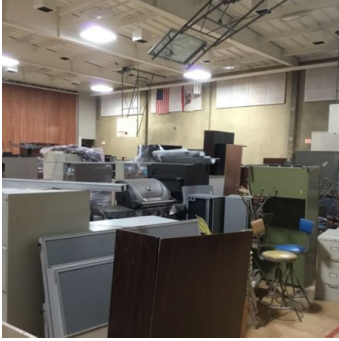
Description: Housekeeping should be improved in this area. Aisles and passageways should be kept clear at all times.

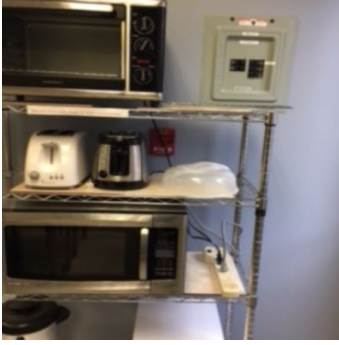
Description: Clear access to the fire alarm pull station should be maintained at all times. Items should not be placed in front of the fire alarm pull station.

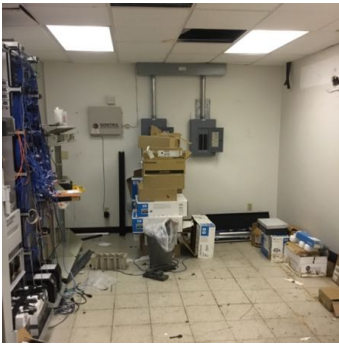
Location: San Bernardino Community College - SAN BERNADINO CCD ANNEX - Data/Electrical Closet

Description: A minimum 36" clearance zone should be maintained around the electrical panel at all times.

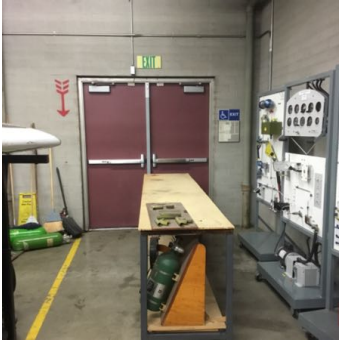
Description: Exits and emergency evacuation routes should be kept clear of obstructions at all times in order to ensure safe egress. Exit and emergency evacuation routes shall be no less than 30" wide at any point.

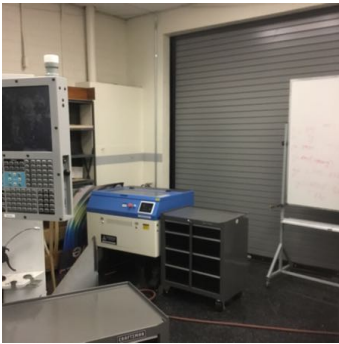
Location: San Bernardino Community College - SAN BERNARDINO VALLEY COLLEGE - Applied Technology Computer Numerical Control Room T112

Description: Clear access to the fire extinguisher should be maintained at all times. Items should not be placed in front of the fire extinguisher. Fire extinguisher locations should be clearly marked with a sign or label.

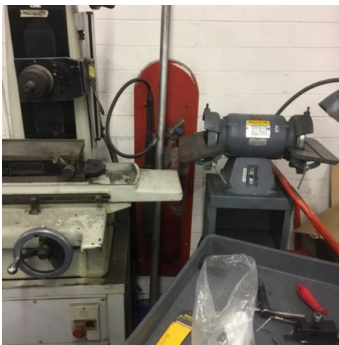
Description: Clear access to the fire extinguisher should be maintained at all times. Items should not be placed in front of the fire extinguisher.

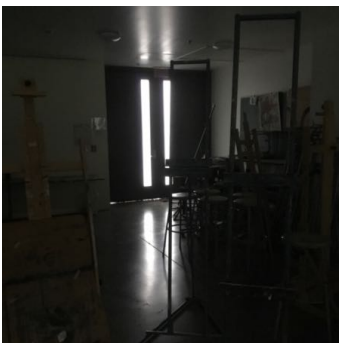
Description: Exits and emergency evacuation routes should be kept clear of obstructions at all times in order to ensure safe egress. Exit and emergency evacuation routes shall be no less than 30" wide at any point.

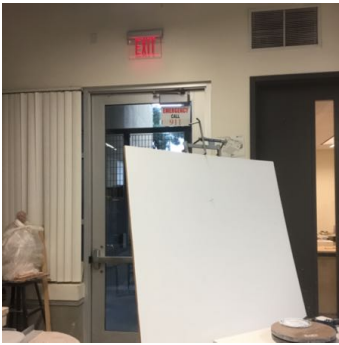
Description: Exits and emergency evacuation routes should be kept clear of obstructions at all times in order to ensure safe egress. Exit and emergency evacuation routes shall be no less than 30" wide at any point.

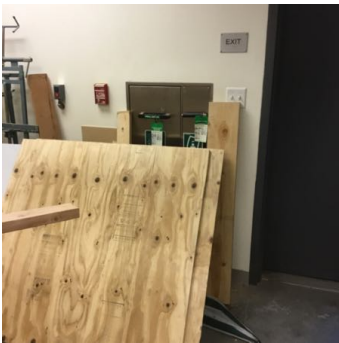
Location: San Bernardino Community College - SAN BERNARDINO VALLEY COLLEGE - Art Center Workroom Art Room 119

Description: The eyewash station and/or deluge shower was obstructed. Clear access should be maintained at all times.

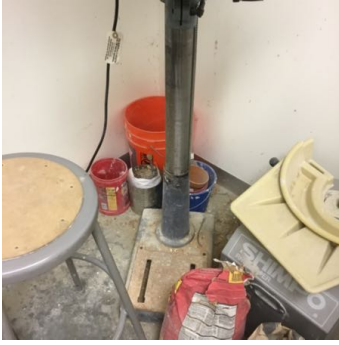
Location: San Bernardino Community College - SAN BERNARDINO VALLEY COLLEGE - Art Center Workroom Art Room 119

Description: Bench top and pedestal mounted equipment such as grinders, miter saws and drill presses should be secured to the bench or the floor in a manner that prevents tipping.

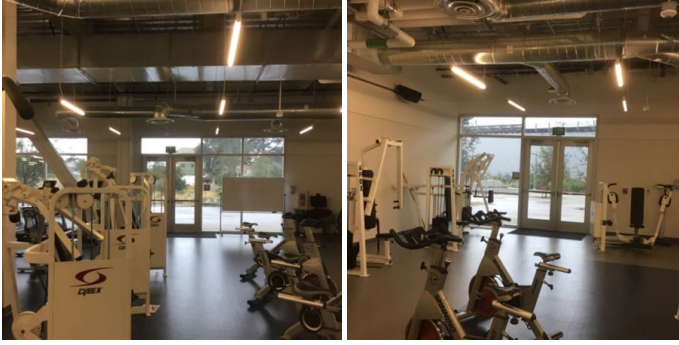
Description: Exit signs should remain illuminated whenever a room or area is occupied. Defective exit signs or illumination bulbs should be repaired or replaced immediately.

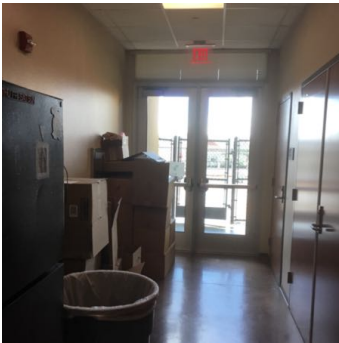
Location: San Bernardino Community College - SAN BERNARDINO VALLEY COLLEGE - KVCR/Media Communications (MC) Building Hallway By Equipment Storage MC 153

Description: Exits and emergency evacuation routes should be kept clear of obstructions at all times in order to ensure safe egress. Exit and emergency evacuation routes shall be no less than 30" wide at any point.

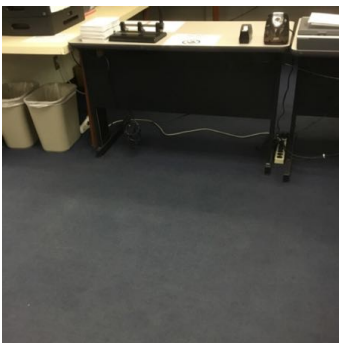
Location: San Bernardino Community College - SAN BERNARDINO VALLEY COLLEGE - LA Building - High Tech Center

Description: Connecting extension cords and/or multi outlet power strips end-to-end presents an elevated risk of fire or circuit overload.

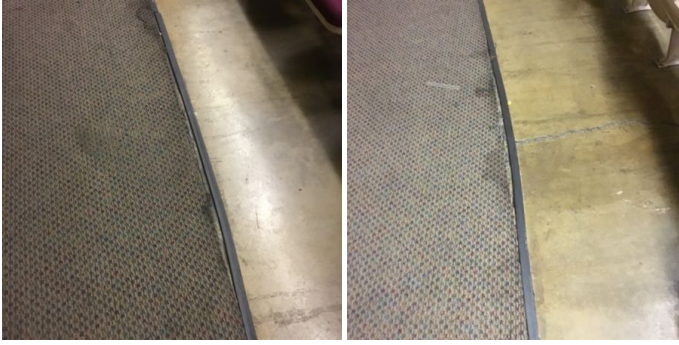
Location: San Bernardino Community College - SAN BERNARDINO VALLEY COLLEGE - LA Building - Lecture Hall LA 100

Description: The vinyl transition strip is loose creates a trip hazard. The vinyl transition strip should be repaired or replaced to reduce this hazard.

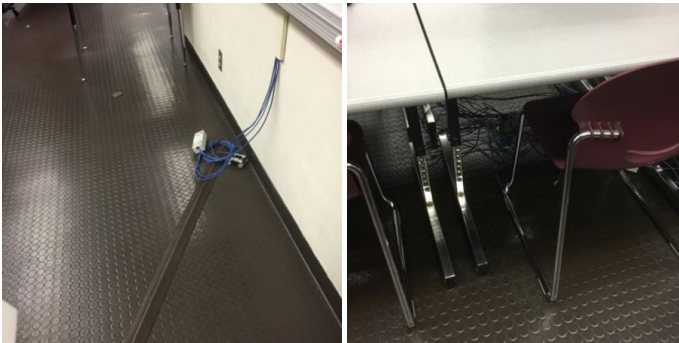
Location: San Bernardino Community College - SAN BERNARDINO VALLEY COLLEGE - LA Building - Reading Lab 206/207

Description: Computer wiring on the floor creates a trip hazard in this area. The computer wires should be re-routed or covered with a floor wire molding to reduce this hazard.

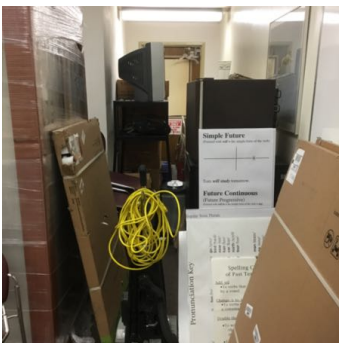
Location: San Bernardino Community College - SAN BERNARDINO VALLEY COLLEGE - LA Building - Writing Center Room LA-201

Description: Exits and emergency evacuation routes should be kept clear of obstructions at all times in order to ensure safe egress. Exit and emergency evacuation routes shall be no less than 30" wide at any point.

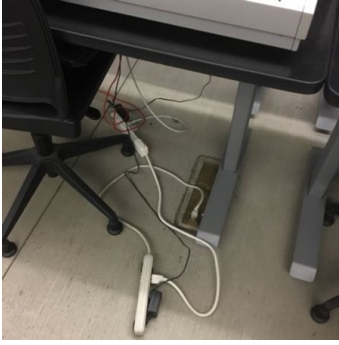
Location: San Bernardino Community College - SAN BERNARDINO VALLEY COLLEGE - Music Lab NH Room 216

Description: Connecting extension cords and/or multi outlet power strips end-to-end presents an elevated risk of fire or circuit overload.

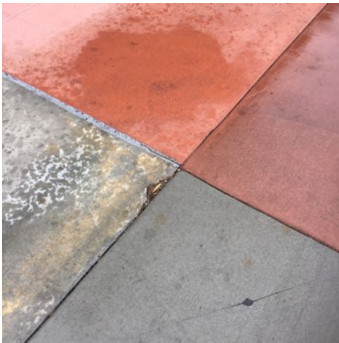
Location: San Bernardino Community College - SAN BERNARDINO VALLEY COLLEGE - Outside Student Health Services

Description: Raised sections of sidewalk or concrete flatwork present a trip hazard. Raised sections of sidewalk or flatwork should be ground down or replaced to reduce this hazard.

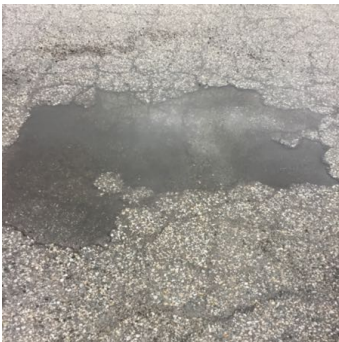
Location: San Bernardino Community College - SAN BERNARDINO VALLEY COLLEGE - Parking Lot 8

Description: Raised or cracked sections of asphalt present a trip hazard. Raised or cracked sections of asphalt should be repaired to reduce this hazard.

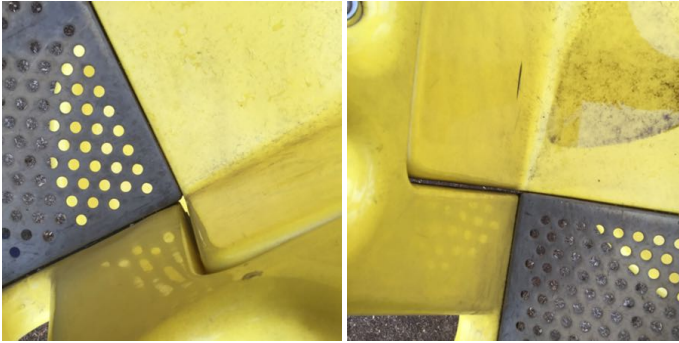
Location: San Bernardino Community College - SAN BERNARDINO VALLEY COLLEGE - PreSchool Play Area

Description: Gaps between the slide bed and the transition platform or between slide sections present

an entanglement hazard. Gaps between the slide bed and transition platform or between slide sections should be eliminated to reduce this hazard.

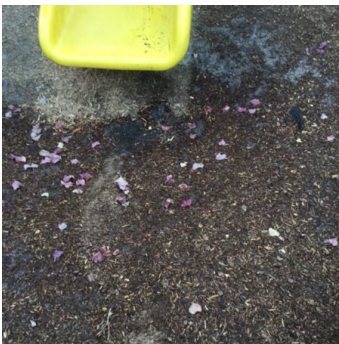
Location: San Bernardino Community College - SAN BERNARDINO VALLEY COLLEGE - PreSchool Play Area

Description: 1. Broken down, compacted or displaced loose fill surfacing material presents an elevated risk of head impact injuries. Adequate loose fill surfacing material depth should be determined based on the fall height of adjacent play equipment. Surfacing material should be added or re-distributed in this area to improve conditions and reduce this risk of head impact injuries. 2. Exposed weed barrier material presents an elevated trip hazard. Exposed weed barrier material should be covered or removed to reduce this hazard.

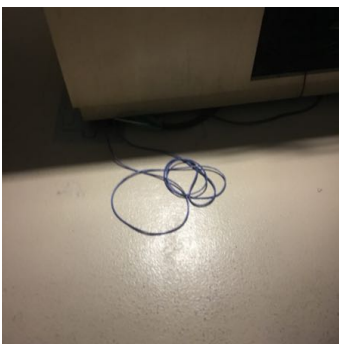
Location: San Bernardino Community College - SAN BERNARDINO VALLEY COLLEGE - PS Math Room PS 107

Description: Computer wiring on the floor creates a trip hazard in this area. The computer wires should be re-routed or covered with a floor wire molding to reduce this hazard.

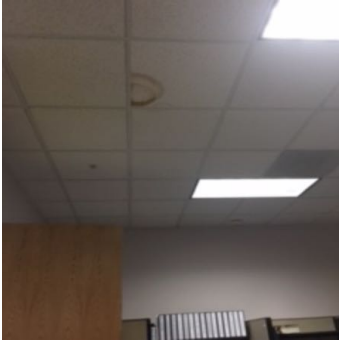
Location: San Bernardino Community College - TECHNOLOGY & EDUCATIONAL SUPPORT SERVICES - Administrative Application Systems

Description: Some of the acoustic ceiling tiles in this area are water stained. The cause of the water stain should be identified and repairs should be made if necessary.

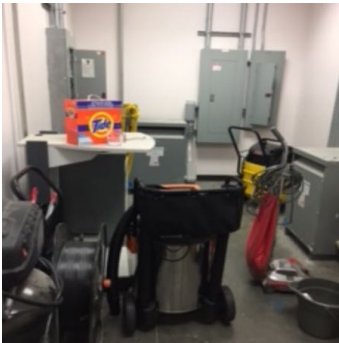
Location: San Bernardino Community College - TECHNOLOGY & EDUCATIONAL SUPPORT
SERVICES - Print Shop Electrical/Custodial

Description: A minimum 36" clearance zone should be maintained around the electrical panel at all times.
