# Volume 1

# Master Plan

CRAFTON HILLS COLLEGE MASTER PLAN  
SAN BERNARDINO COMMUNITY COLLEGE DISTRICT

Volume 3 Existing Facilities Assessment

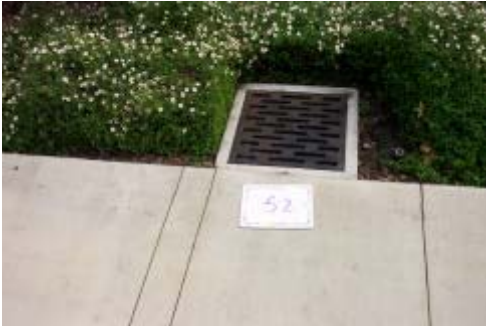
Figure 1 - Typical site catch basin that collects surface drainage.

- Isolated areas adjacent to buildings that lack sufficient gradients to allow surface drainage to area drains or catch basins.
- Areas on concrete flatwork that lack sufficient gradient to direct surface drainage to catch basins.
- Catch basins and inlets appear to be in good condition and function adequately.
- Small diameter drains appear to function adequately.
- Large diameter storm drains appear to be well maintained and function properly.
- Channel located along the northerly side of Campus Drive has developed into a natural creek. The channel appears to have adequate capacity to convey site drainage. The channel requires annual maintenance to restrict growth of vegetation.
- Retention basin located in the vicinity of Campus Drive and Sand Canyon has filled with silt and is overgrown with vegetation.

- Add area drains and catch basin in landscape areas where surface drainage is poor and ponding occurs.
- Replace hardscape areas where ponding occurs.
- Remove vegetation and silt from the retention basin to allow the basin to function properly.

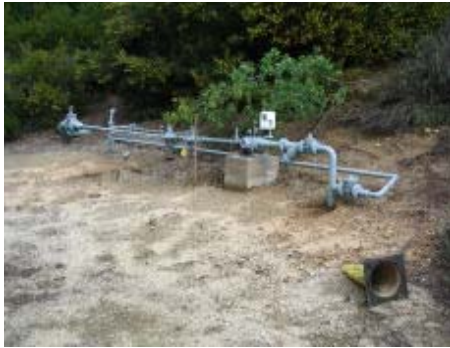
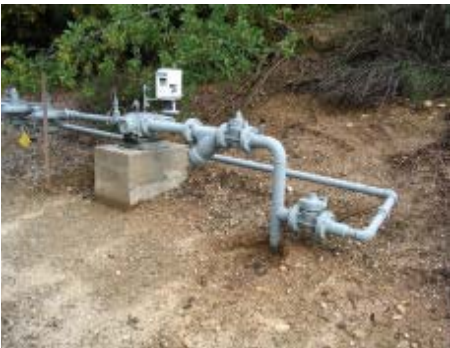
## Campus Master Gas Meter

- The master gas meter is located on west of the campus.
- High pressure gas is supplied to the meter by Gas Company. Gas Company's gas pressure regulators reducing the pressure to 3 to 5 PSI (to be verified).

- A 6" painted gas line appears to be black steel enters underground and delivers gas to the campus.
- Above ground piping appears to be in fair condition.

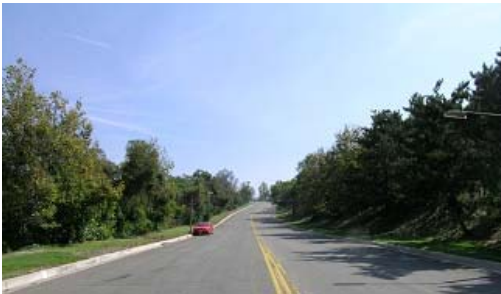
**Figure 2.2:** Campus Drive

- Mass plantings of native and non-native trees and shrubs border either side of Campus Drive at the College entries (Figure 2.2). As an entry drive, the landscape lacks definition or visual cues.

- Enhancement of the landscape along Campus Drive and at the marquee gateways can make the campus entry more welcoming and memorable for visitors. The three marquee gateways can share a more distinct and related design that visually connects them to each other and better defines each one as a destination marker.
- Secondary/service roads do not extend to all buildings. Even if the road connects to a building, it is not always the most direct route, as seen with the Performing Arts Center loading dock. College personnel and delivery drivers will use pedestrian walkways as alternative routes to gain closer access to buildings, resulting in damage to paving, plants and equipment (see Figure 2.8).
- Parking lot entrances/exits get congested when traffic volume is high.

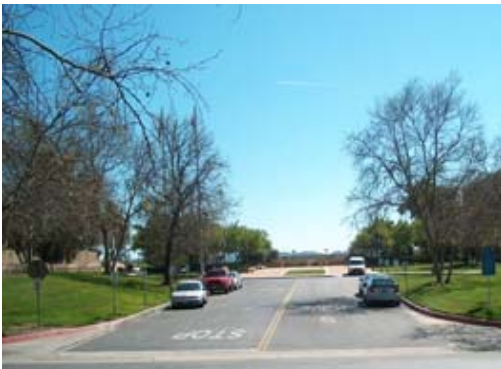
**Figure 2.3:** Central Entry at Parking Lot D

- The Central Entry at parking lot D includes limited parking, a bus stop and visitor drop-off area (Figure 2.3). The marquee sign identifies this arrival point, but the space lacks visual impact. Although visitors enter the heart of the campus, (i.e., the Central Quad) from this point, they will not be aware of this until they stand in the middle of the Central Quad.

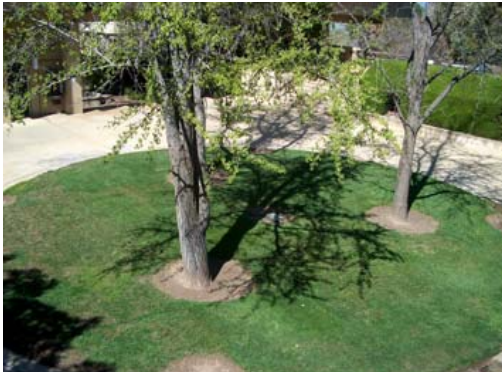
**Figure 4.8:** The SSA Green with its lawn area and Ginkgo trees

- The lawn in the SSA Green is a maintenance issue since mowers must be carried up and down the steps (Figure 4.8). Replacing the lawn with groundcover or hardscape material can alleviate this problem.

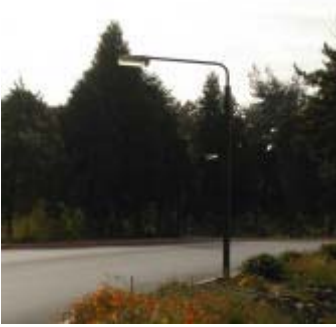
Figure 1.1 – Street lighting - restricted height and wide spacing lead to uneven lighting.

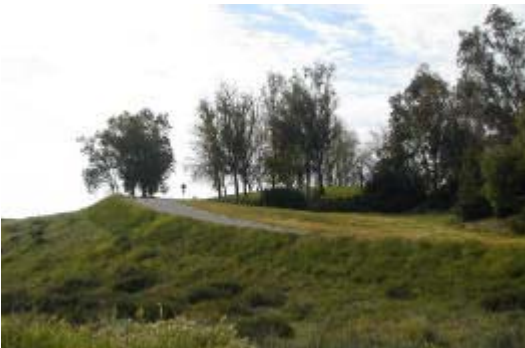
Figure 1.4 – Service road - unilluminated

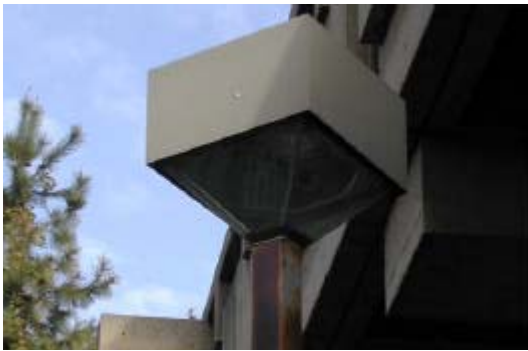
Figure 2.2 – Post top at top of stairs – Pedestrians see into fixture when ascending stairway.

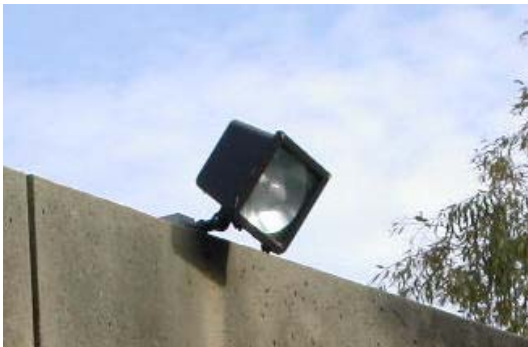
Figure 2.3 – Student Services – floodlight illuminating stairs partially blinds pedestrians.

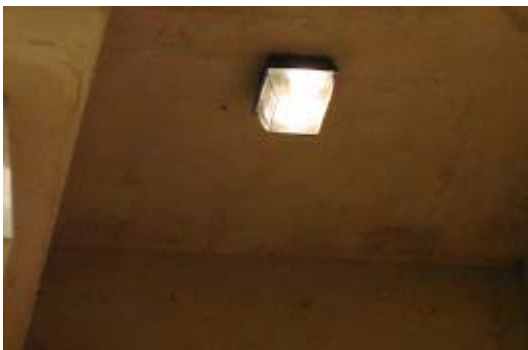
Figure 2.4 – Ceiling mount fixture – where visible, fixture is major source of glare.

- Fixtures using visible lamps (including pole lights, wall packs, and floodlights) actually reduce visibility.

- Fixtures that currently produce high amounts of glare should be replaced with full cut-off fixtures where optical control is imperative and diffuse, low brightness fixtures where unsophisticated optics are required.

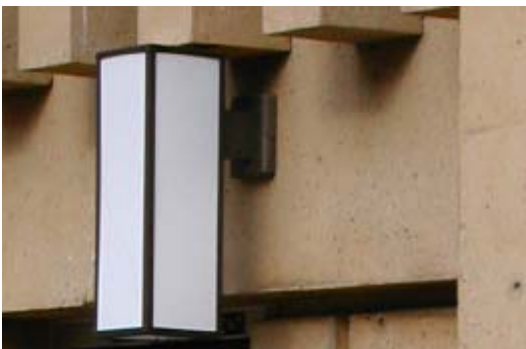
Figure 3.3 – New wall sconces – These use fluorescent, for moderate to good color rendering.

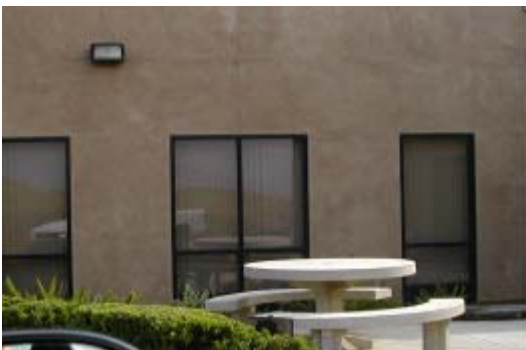
Figure 3.4 – High pressure sodium – Environments appear various shades of gold and brown.

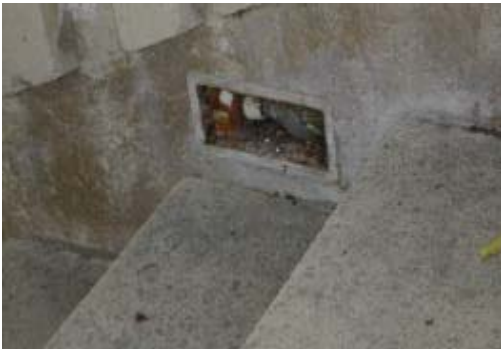
Figure 5.3 – Steplights with polycarbonate lenses will eventually fall to vandalism.

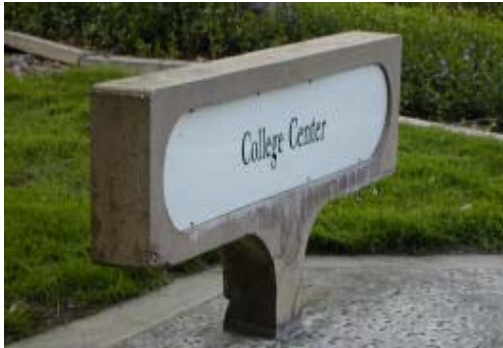
Figure 10.1 – Existing building signage is internally illuminated, although unevenly.

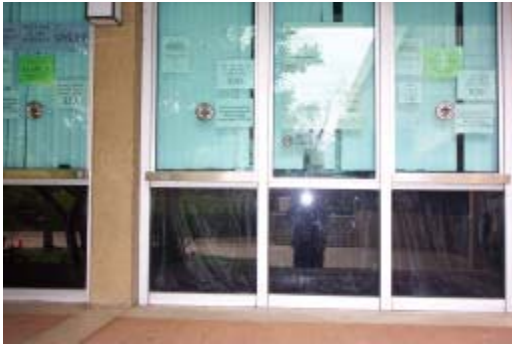
Figure 1 – Four “cashier” windows in the Registration Office, from the outside.

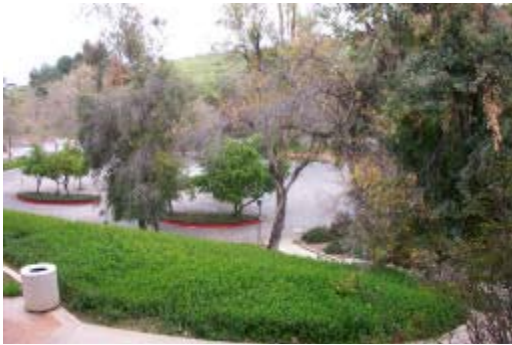
Figure 3 –Lot “B” from opposite the SSA Building

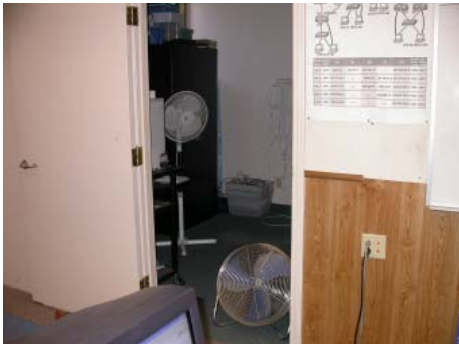
**Inadequate ventilation** - Office converted for use as server room. Existing systems cannot handle heat load.

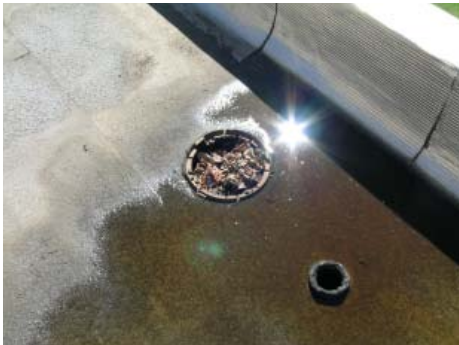
**Roof at first level south** - Clogged drains, blistering and ponding are common problems.

- Roofs show signs of water ponding.
- Roof and overflow drains are filled with debris.
- The strainer is missing from many of the drains, causing drains to become clogged

- Patched roof areas are
- Severe blistering throughout the roof, blisters as high as 2-3 inches.
- Blisters in some areas have started to crack, creating areas for potential leaks.

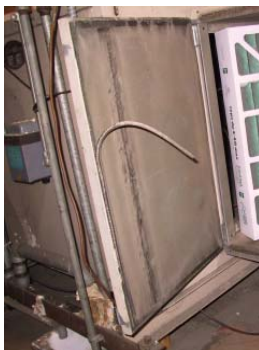
**Figure 3** – Example of door gaskets that need to be replaced.

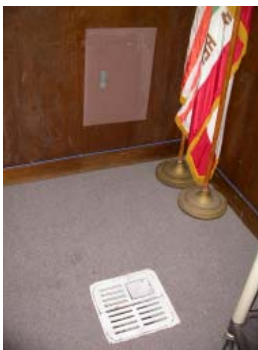
**Crafton Center** - Exposed electrical panel and floor drain.

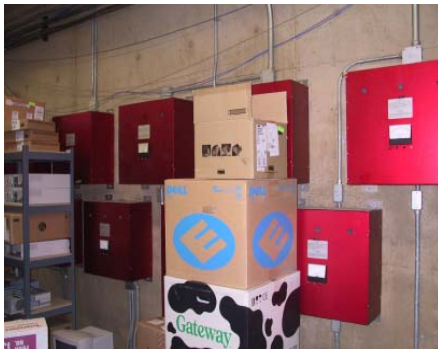
Figure 3 – Simplex fire alarm equipments

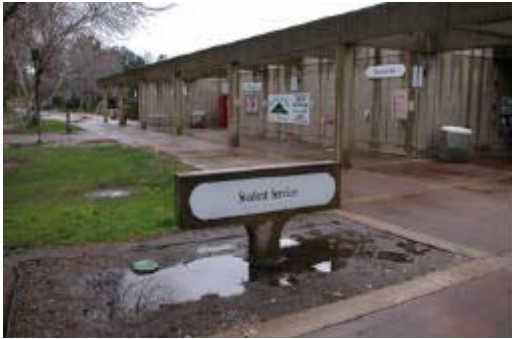
Figure 1 – View of freestanding building identification sign.

Existing freestanding illuminated concrete sign is showing signs of decay. Scale of the sign and its copy is too small for larger buildings. Concrete sign is not visible as it blends with concrete architecture. Illuminated sign panel is too small to identify buildings with several names, uses or departments. Exposed screws are visible in sign face. Illuminated faces do not provide the best copy visibility.

Repair concrete and sandblast to clean. Retrofit lamping and wiring. Replace acrylic panel with painted aluminum panel with routed out copy so that just the copy illuminates.
